Report of Flux Leakage Inspection

Eclipse: STEAM BOILER

Serial: 47153

Location: USA SCHOOL
3355 First Steet
SOMEWHERE, US 00002

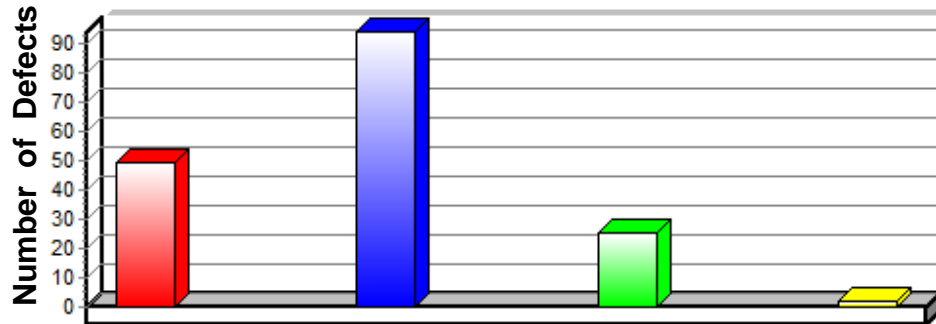
Boiler Defects

- OD PIT 20% - 39%
- OD PIT 40% - 59%
- OD PIT 60% - 79%
- POSSIBLE LEAK

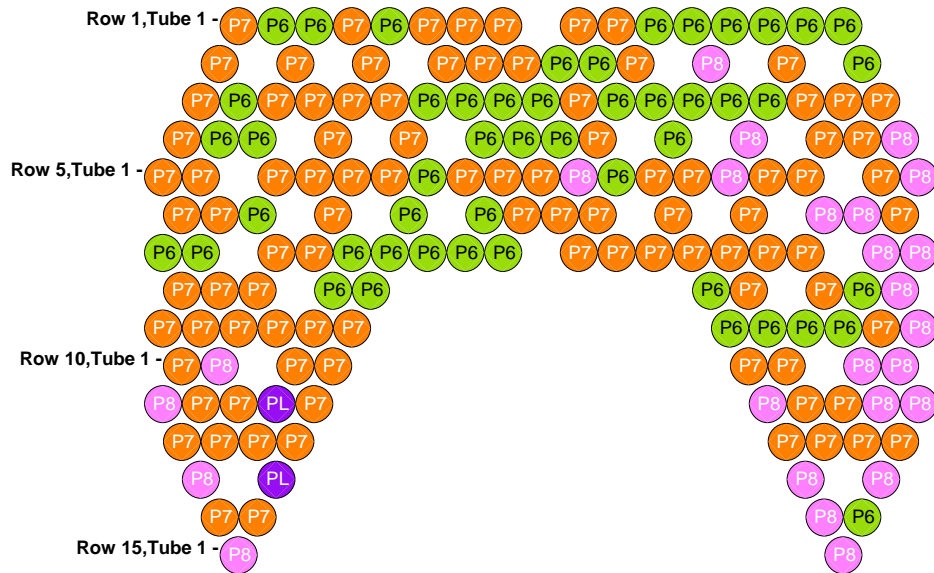
Boiler Section

- P6 = OD PIT 20% - 39%
- P7 = OD PIT 40% - 59% **REQUIRES ACTION**
- P8 = OD PIT 60% - 79% **REQUIRES ACTION**
- PL = POSSIBLE LEAK **REQUIRES ACTION**

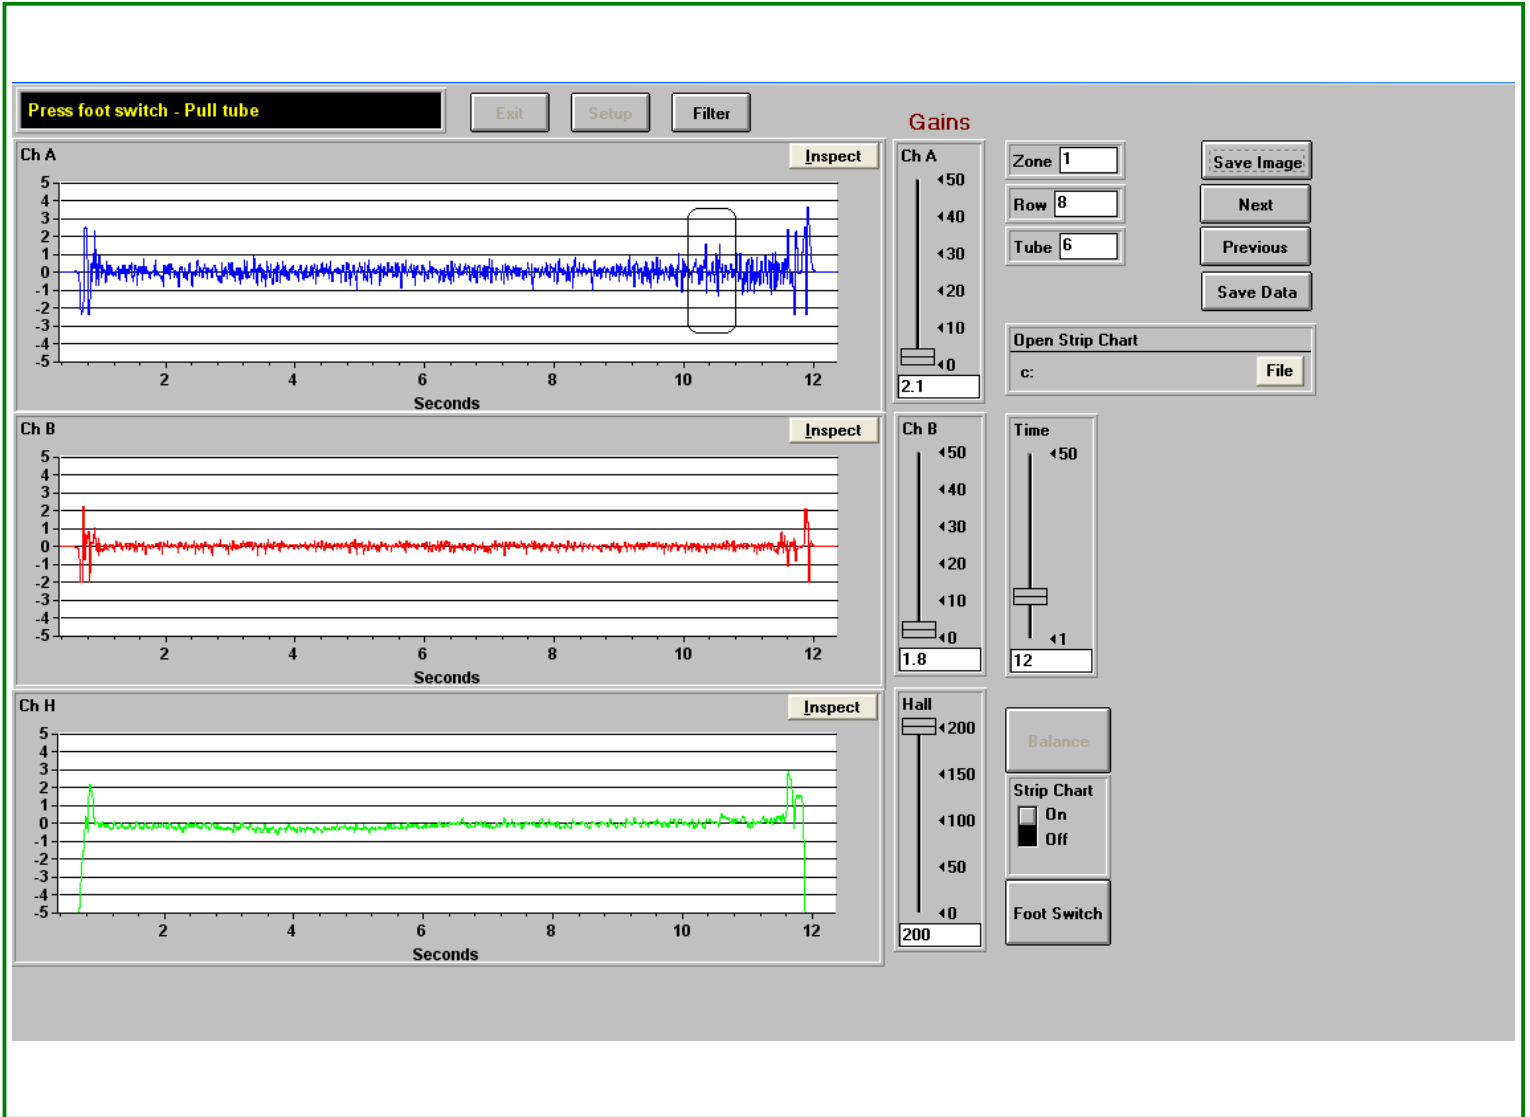
OD PIT 20% - 39% (Row 8 Tube 6)

We recommend tubes indicating OD Pits of 40% or more be isolated from the system at this time. Tubes indicating OD Pits of less than 40% require no corrective action but should be monitored for defect growth.

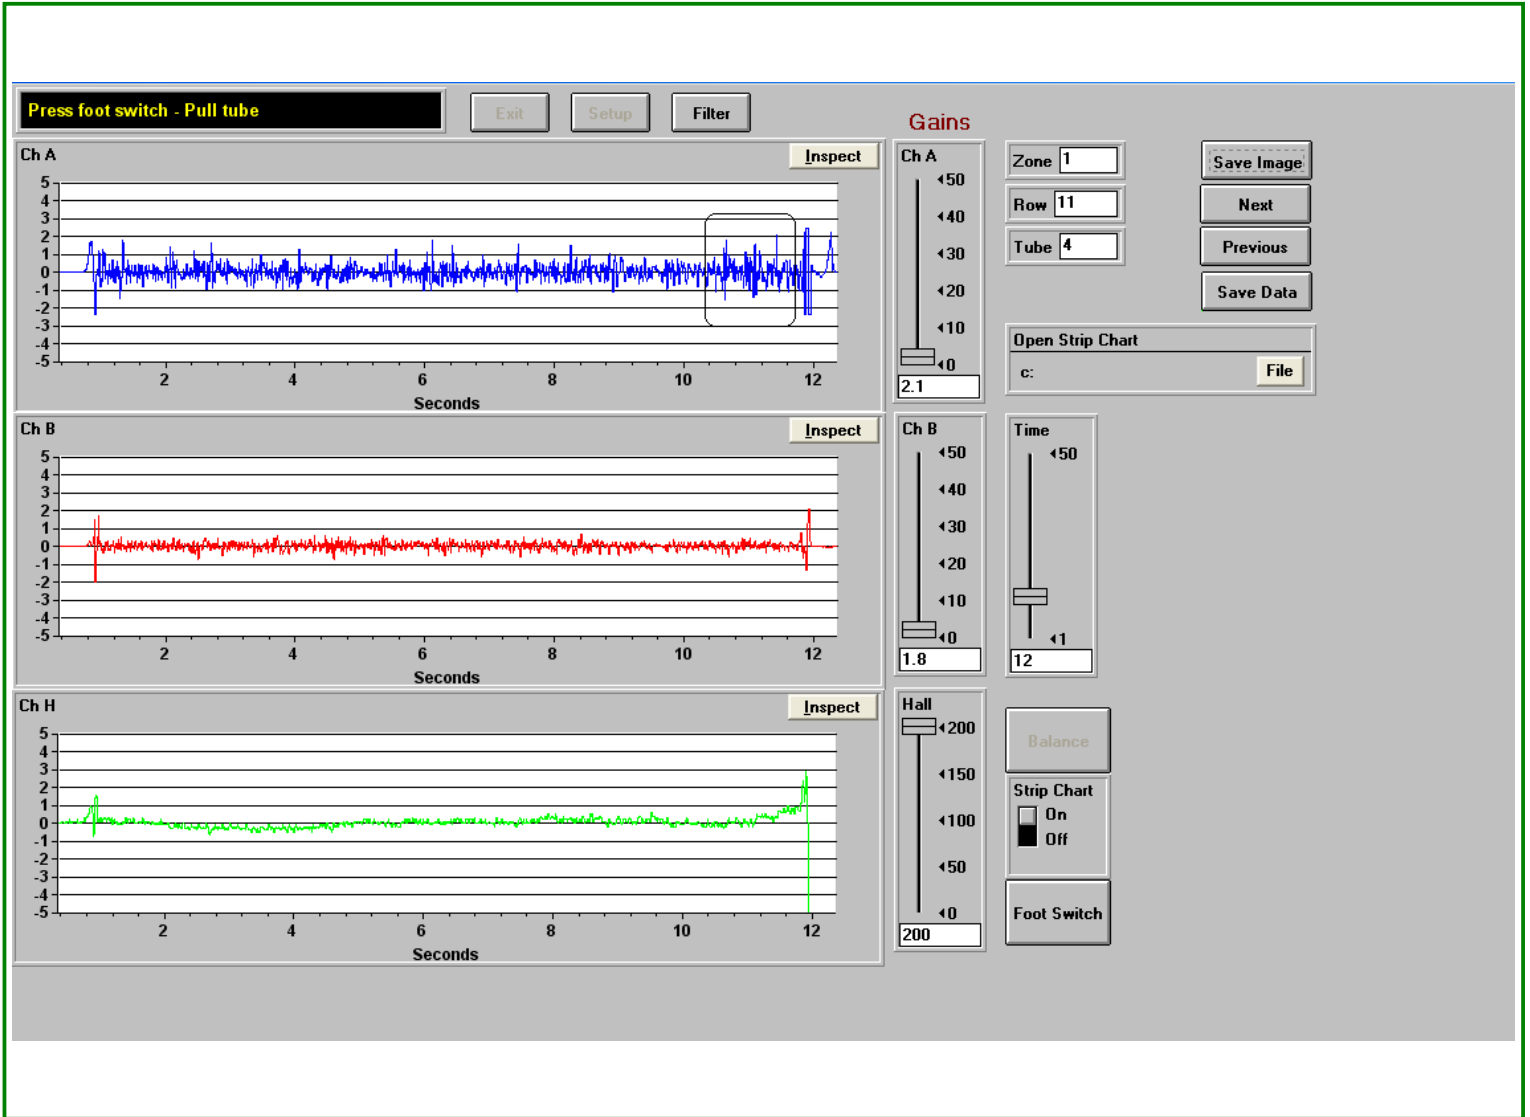
POSSIBLE LEAK (Row 11 Tube 4)

We recommend tubes marked for leaks be isolated from the system at this time.

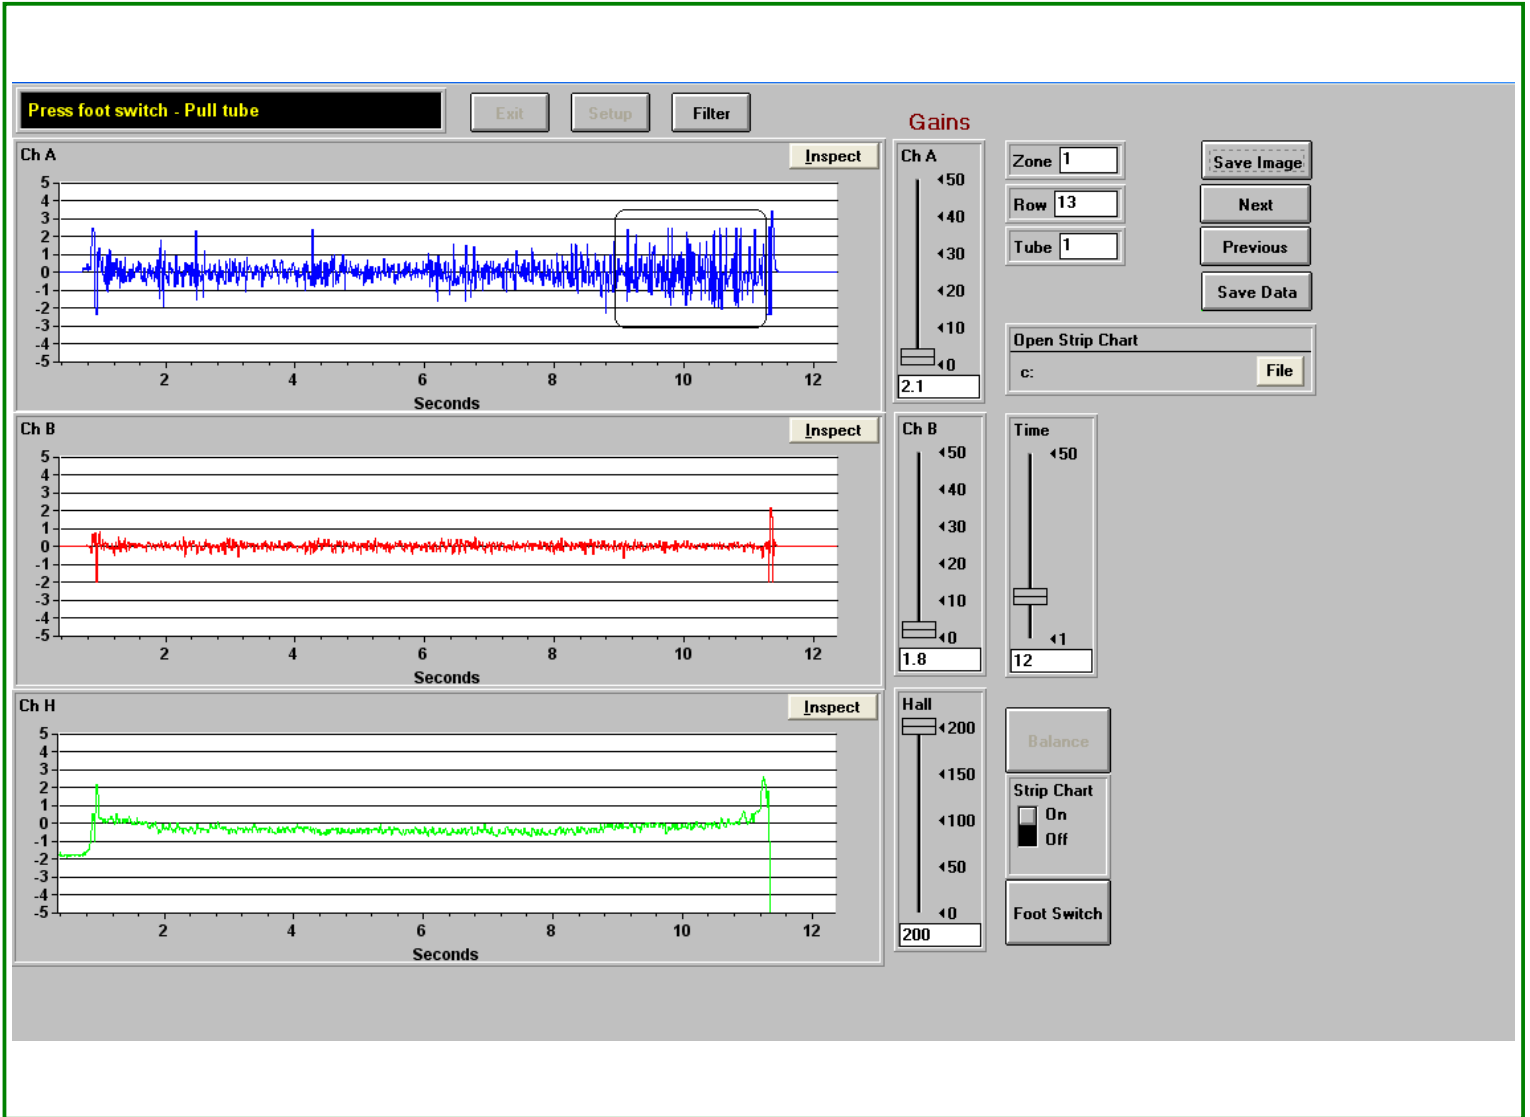
OD PIT 60% - 79% (Row 13 Tube 1)

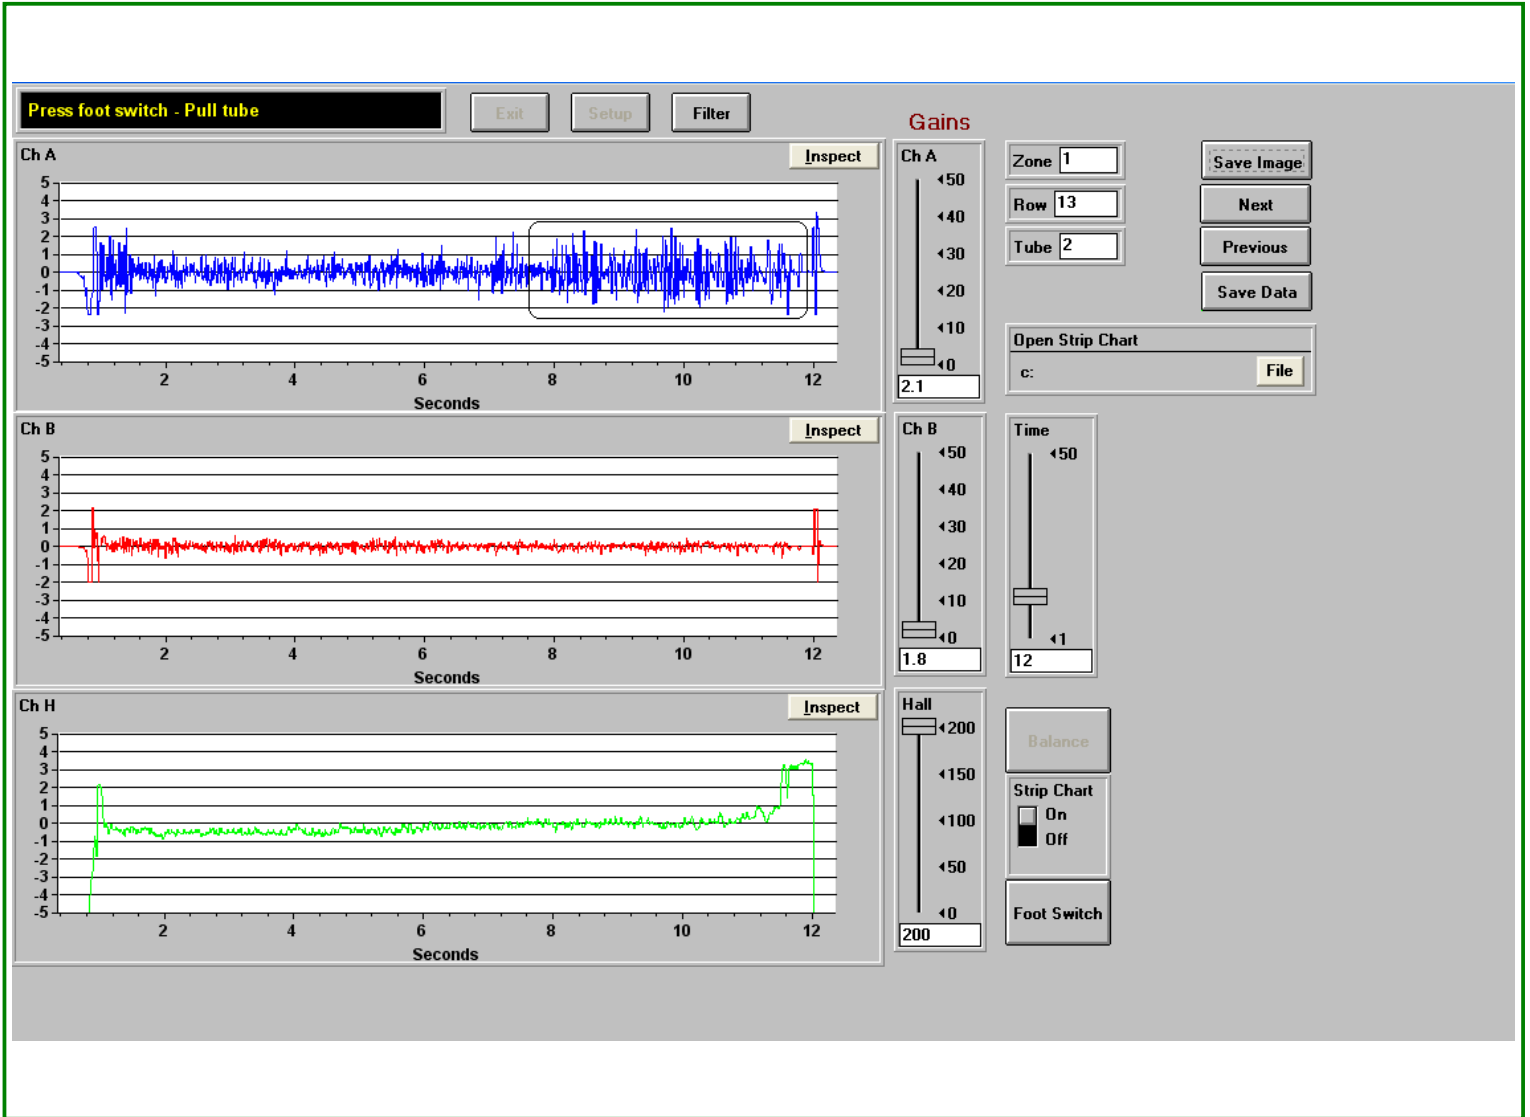
POSSIBLE LEAK (Row 13 Tube 2)

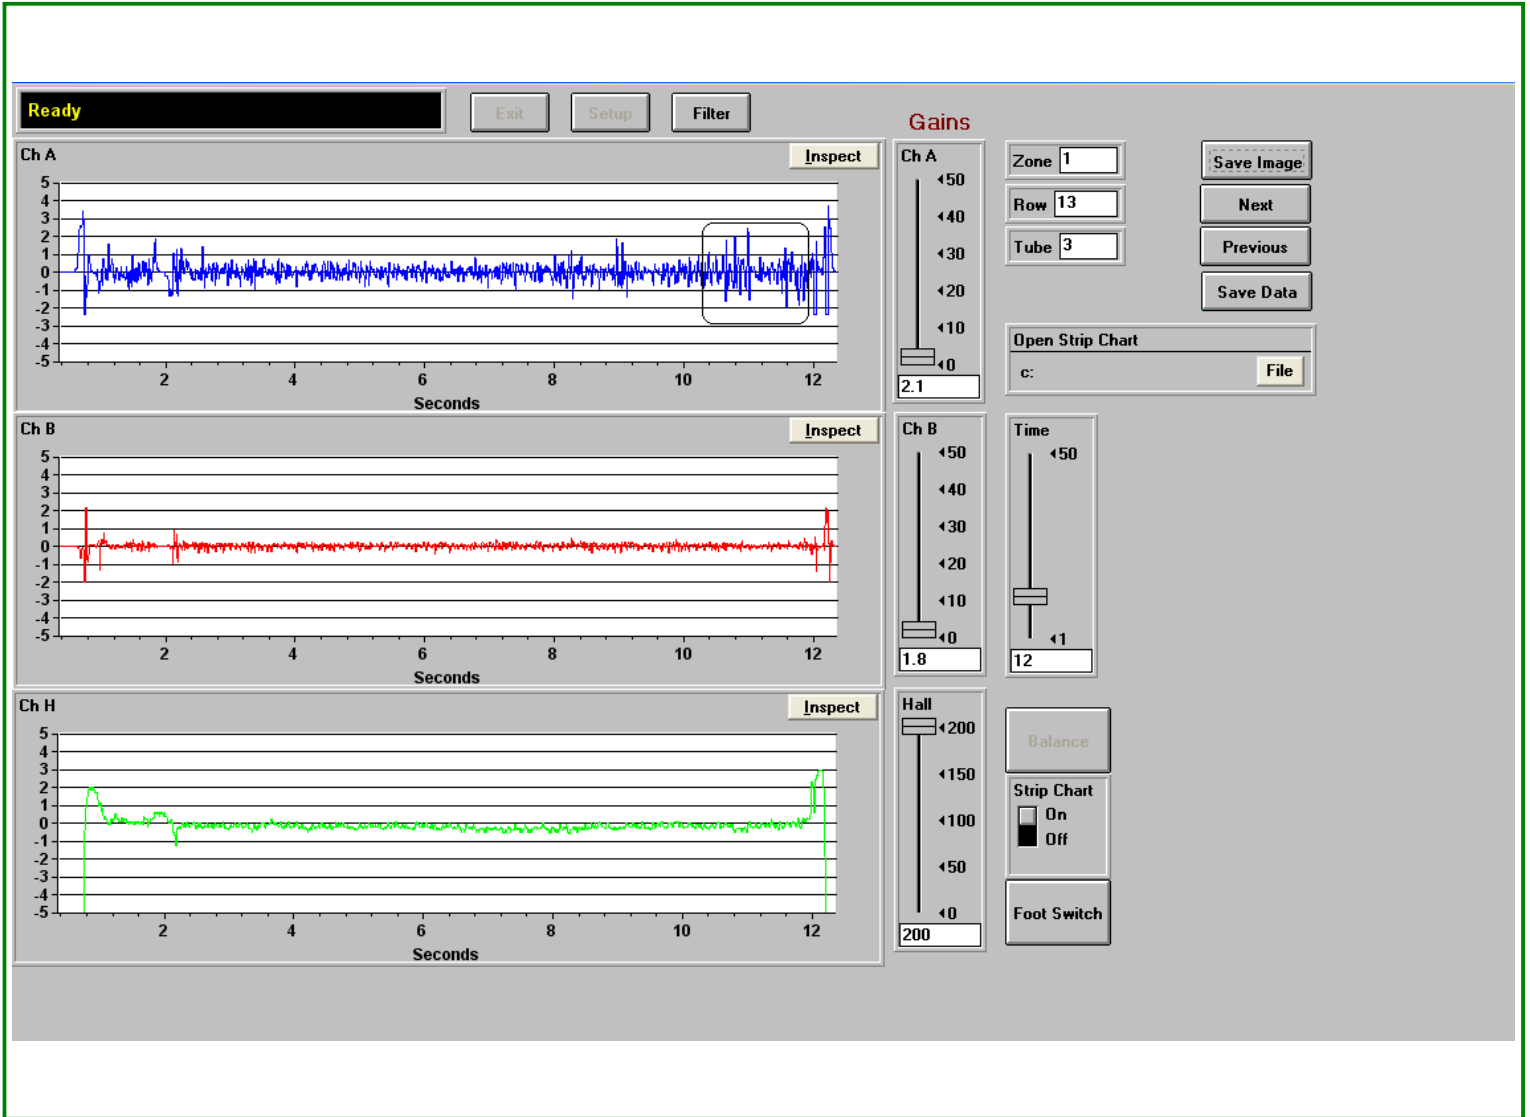
OD PIT 60% - 79% (Row 13 Tube 3)

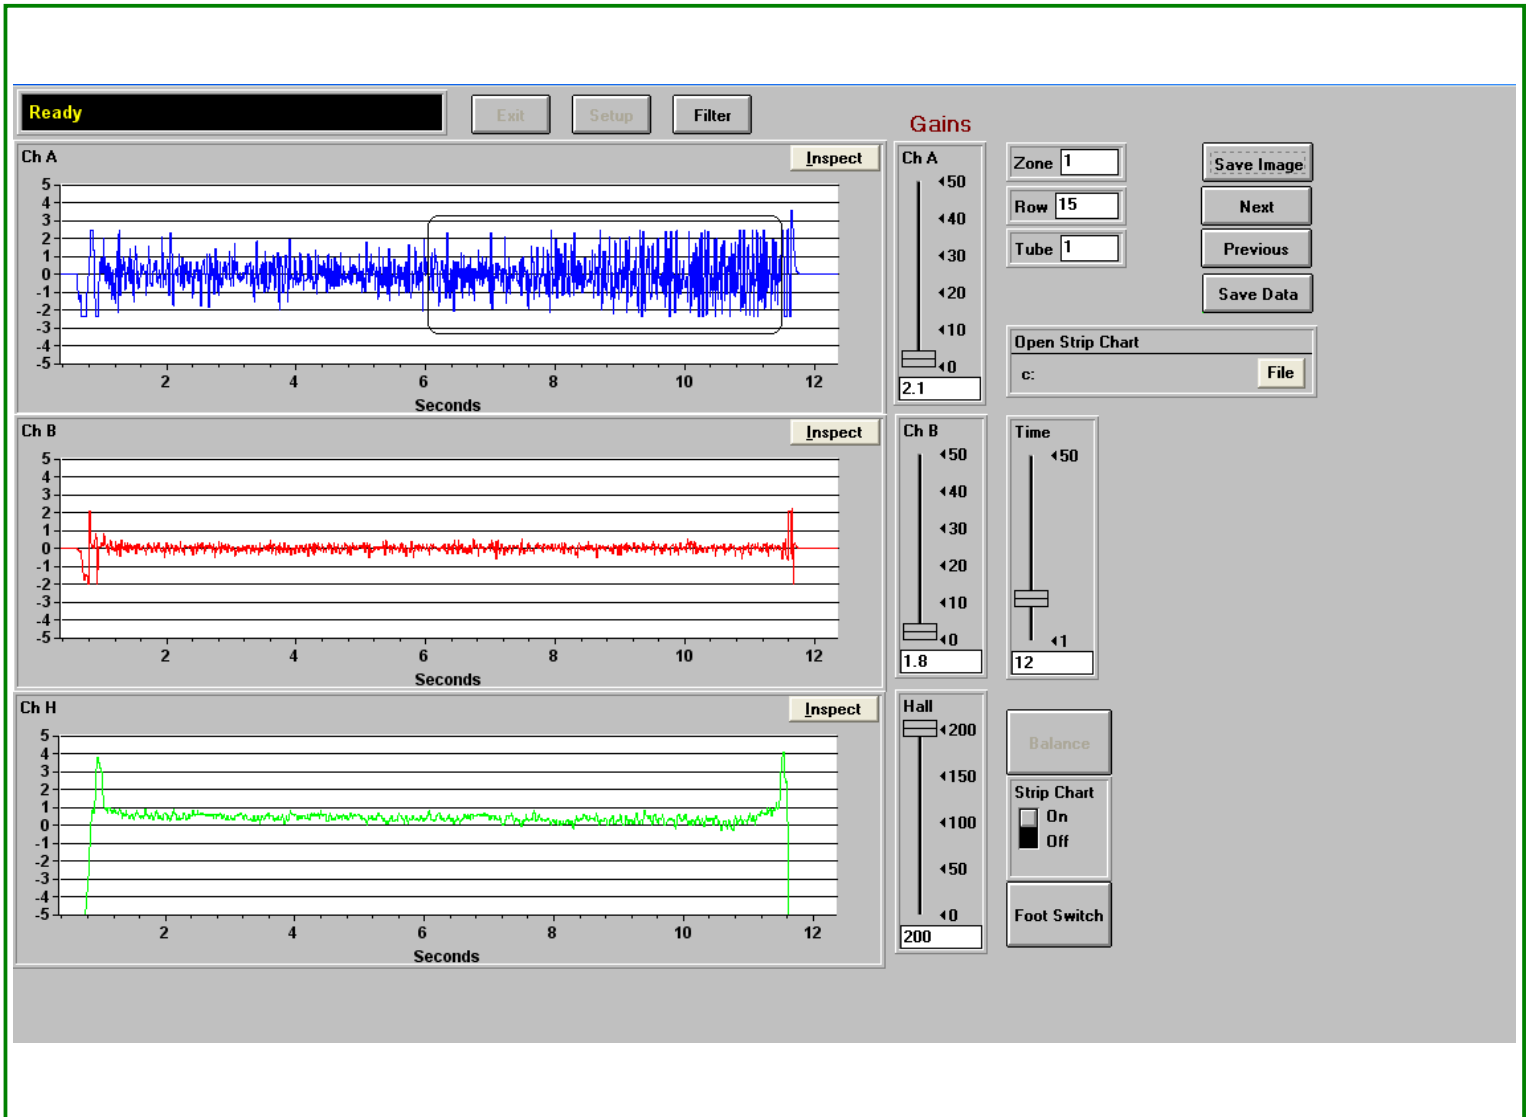
OD PIT 60% - 79% (Row 15 Tube 1)

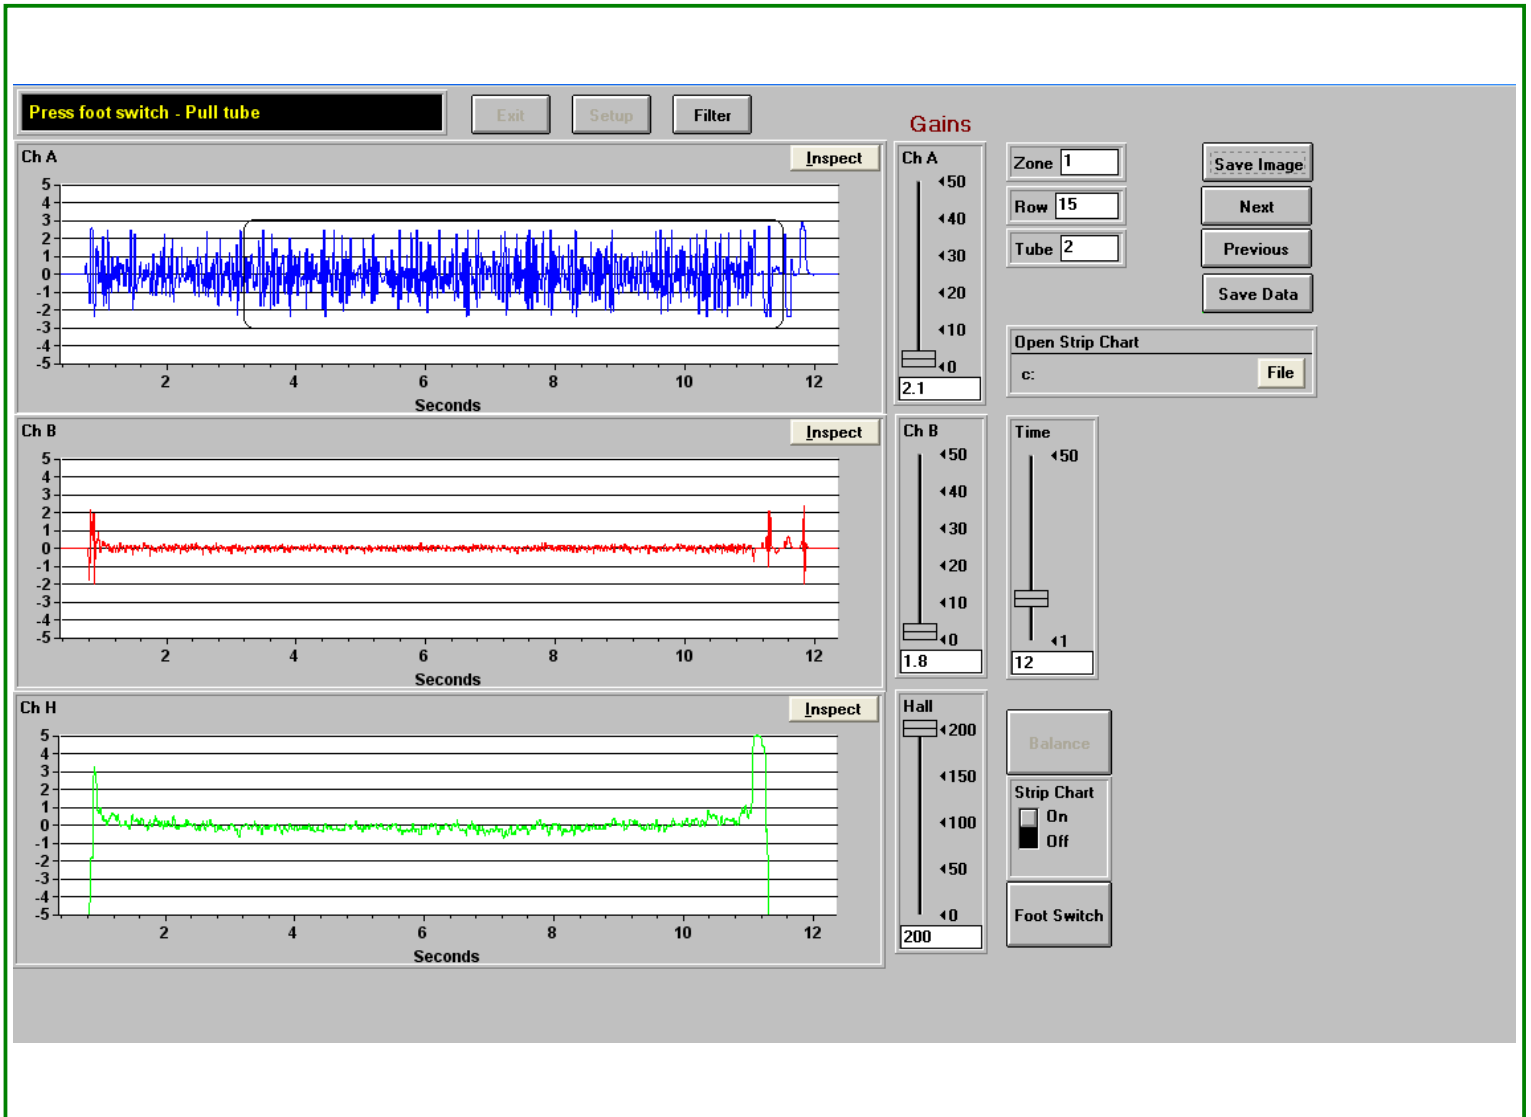
OD PIT 60% - 79% (Row 15 Tube 2)
