Report of Flux Leakage Inspection

PACIFIC: P425A10

Serial: 207653 #1

Location: WIN-BIG
CASINO, TX 75201

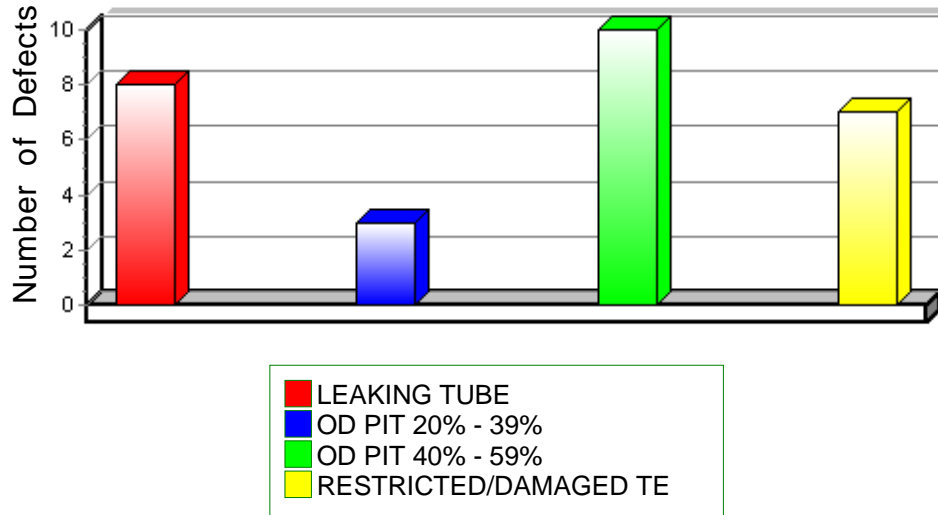
Boiler Defects

Boiler: 186 Tubes		
Significant/Measurable Indications	Number of Tubes	Percent of Bundle
RESTRICTED/DAMAGED TE	7	3.76
LEAKING TUBE	8	4.30
OD PIT 20% - 39%	3	1.61
OD PIT 40% - 59%	10	5.38
Totals	28	15.05

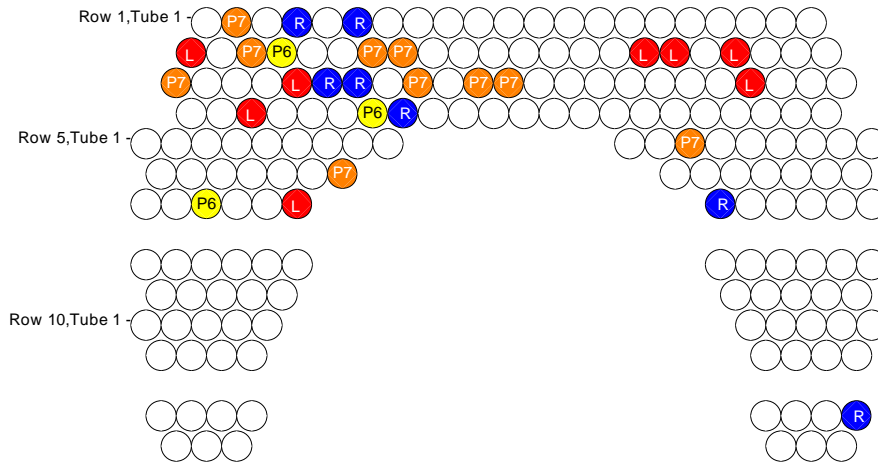
Boiler Section

- R = RESTRICTED/DAMAGED TE
- L = LEAKING TUBE
- P6 = OD PIT 20% - 39%
- P7 = OD PIT 40% - 59%

Tubes marked as Restricted/Damaged, were inaccessible due to the tube end at the test end being damaged. This damage prevented the inspection probe from being inserted into the tube. These tubes were not inspected and their condition remains unknown.

We recommend tubes marked for leaks be isolated from the system at this time. These tubes were indicted as leaking prior to the inspection.

We recommend tubes indicating OD Pits of 40% or more be isolated from the system at this time. Tubes indicating OD Pits of less than 40% require no corrective action but should be monitored for defect growth. We further recommend this tube bundle be pressure tested for leaks that may have been undetectable.

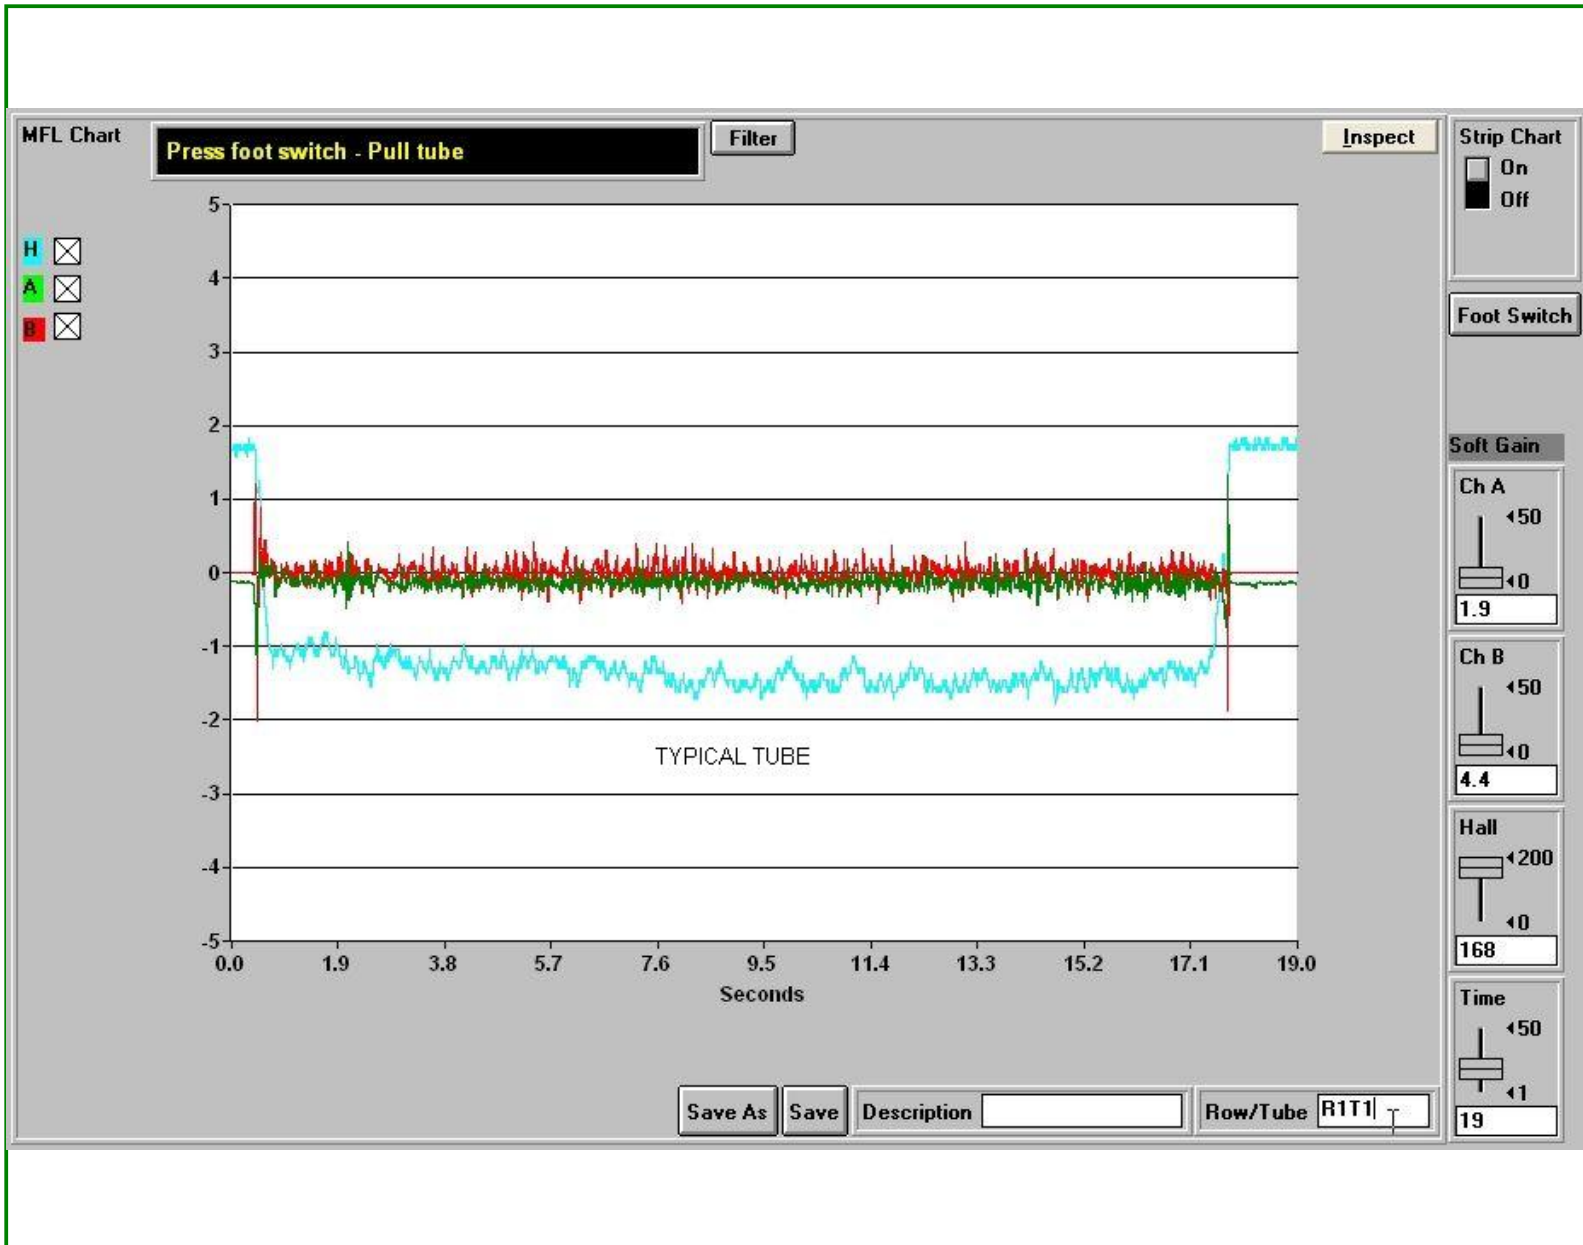
Boiler Section

NO SIGNIFICANT DEFECTS

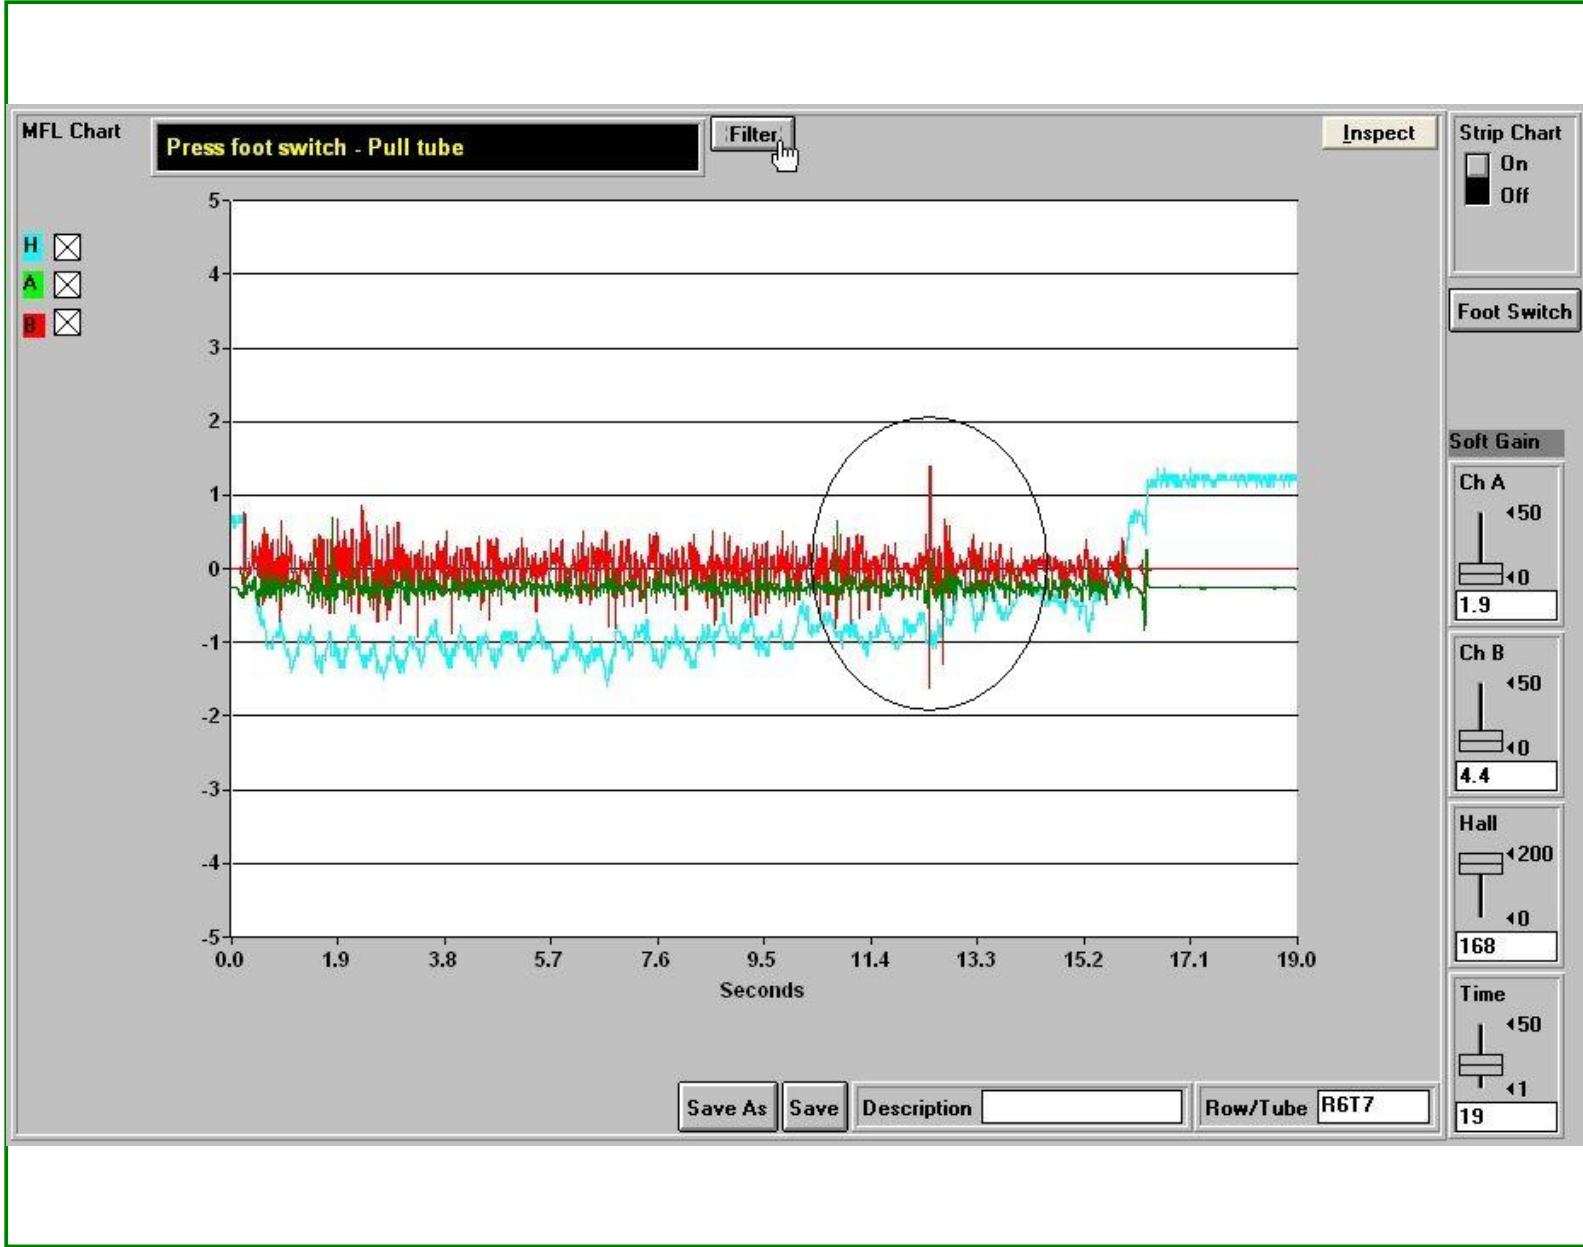
Boiler Section

OD PIT 40% - 59%
