SAMPLE INFRARED REPORT  
BLUEGRASS LAKES PKWY  
CITY, STATE 12345

TAI SERVICES, INC.  
INFRARED INSPECTION

**SURVEY DATE:** AUGUST 9, 2001

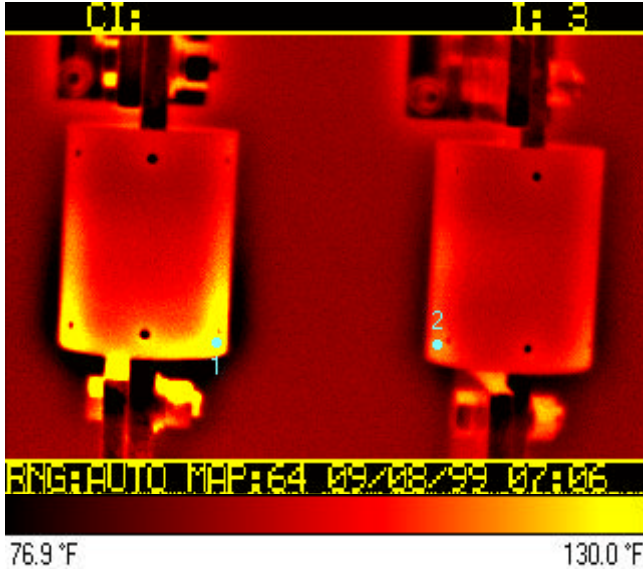
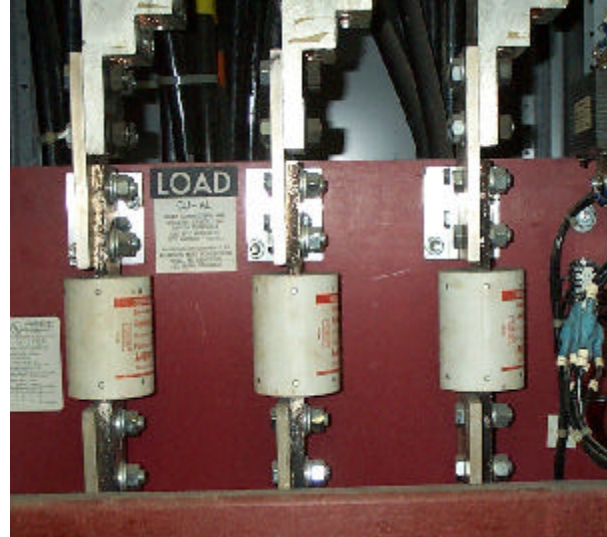
# THERMOGRAPHIC REPORT 1

**LOCATION:** MAIN DISTRIBUTION ROOM

**COMPONENT:** MAIN No. 3 PNL

**PHASE:** B, (LINE SIDE)

**TEMPERATURE RISE:** 13.8° OVER PHASE "C",

**PROBLEM:** POSSIBLE WEAK FUSE

**RECOMMENDATION:** INVESTIGATE

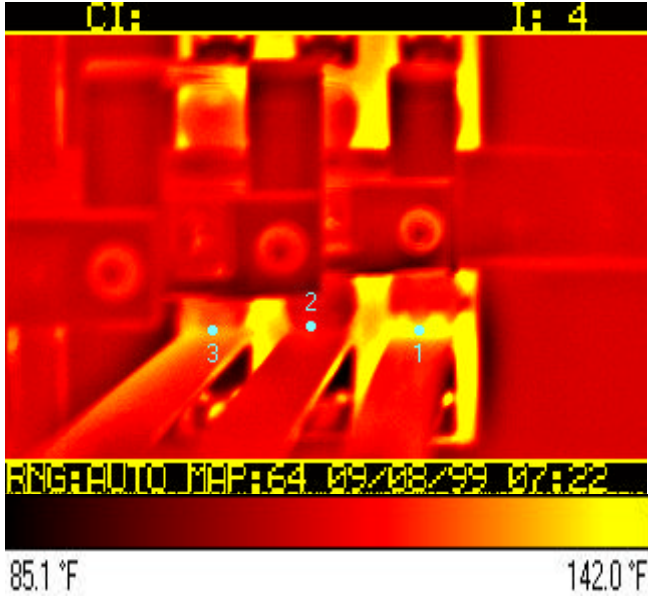
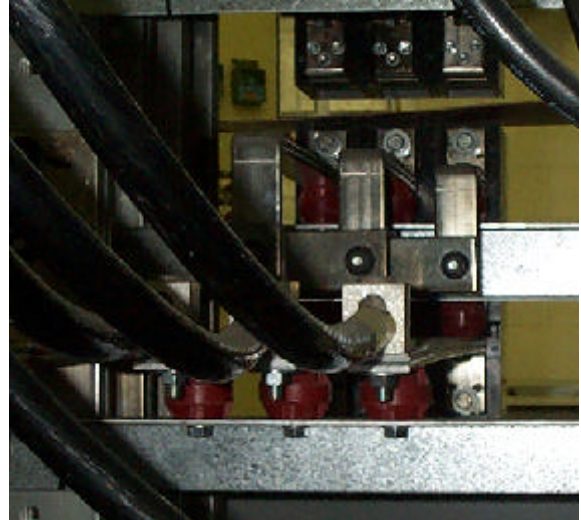
# THERMOGRAPHIC REPORT 2

**LOCATION:** MAIN DISTRIBUTION ROOM

**COMPONENT:** BREAKER PPI (YELLOW PHASE)

**PHASE:** C, LINE SIDE

**TEMPERATURE RISE:** 27.8 OVER PHASE "B"

**PROBLEM:** POSSIBLE UNBALANCED CIRCUIT

**SEVERITY:** MODERATE

**RECOMMENDATION:** INVESTIGATE

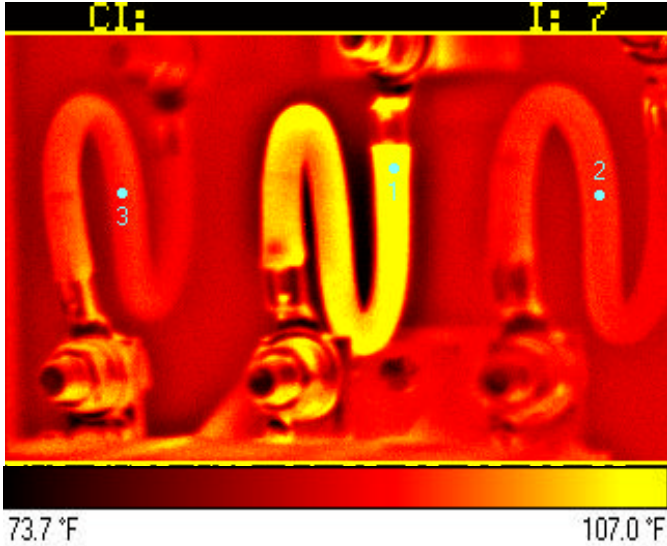
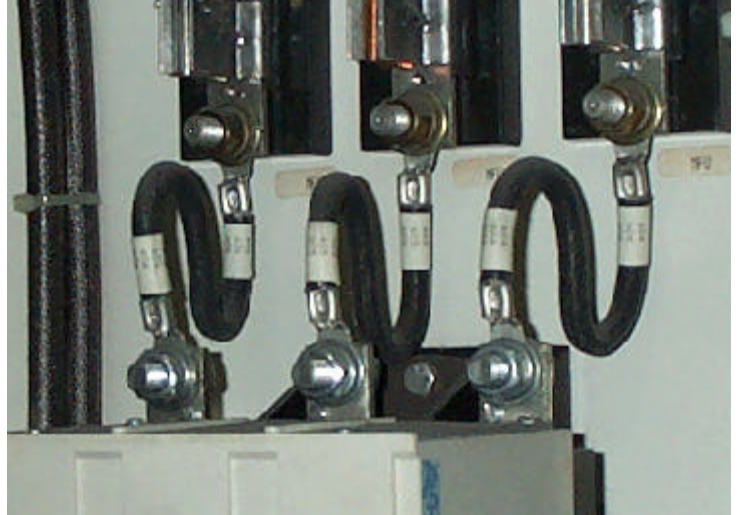
# THERMOGRAPHIC REPORT 3

**LOCATION:** PRESS 1

**COMPONENT:** LN 1 RELIANCE CAB

**PHASE:** B, (LINE SIDE)

**TEMPERATURE RISE:** 14.5° OVER PHASES "B" & "C",

**PROBLEM:** POSSIBLE LOOSE LUG AT FUSE.

**RECOMMENDATION:** INVESTIGATE, TIGHTEN

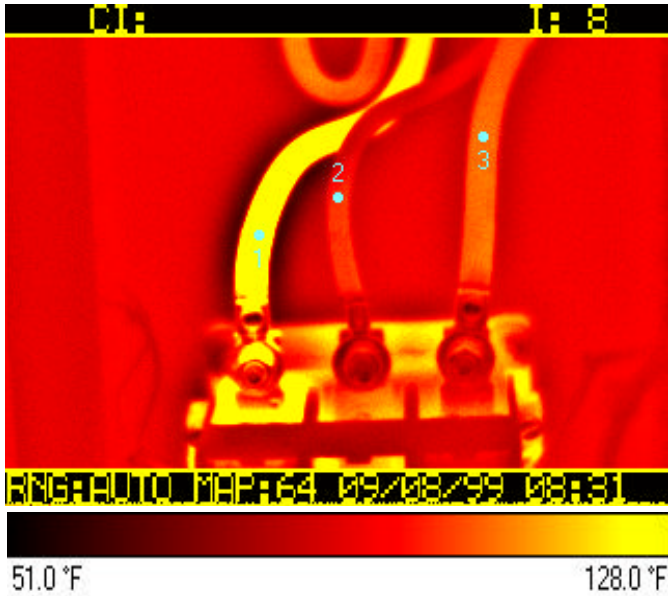
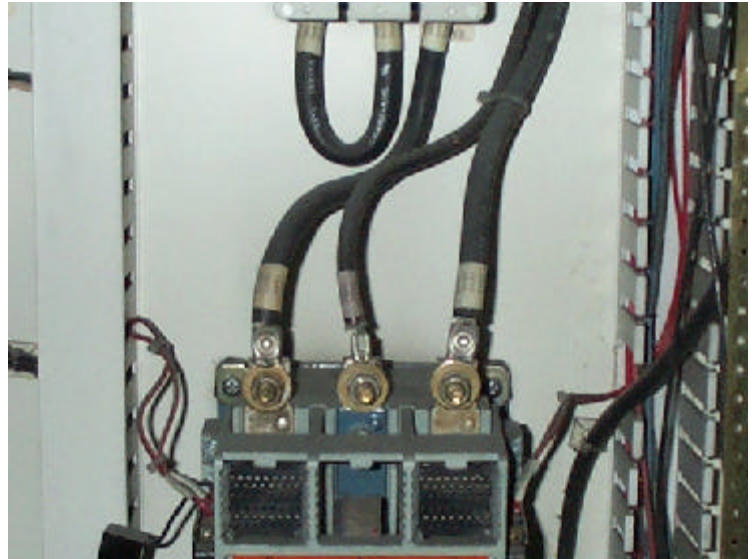
# THERMOGRAPHIC REPORT 4

**LOCATION:** PRESS 1

**COMPONENT:** PRM CONTACTOR, (WIRE NO. 1849)

**PHASE:** A

**TEMPERATURE RISE:** 30.8° OVER PHASE "B"

**PROBLEM:** POSSIBLE CIRCUIT UNBALANCE
