## Report of Eddy Current Inspection

Manufacturer: York

Model: YT-B2-B2-B2

Location: HIGH RISE ONE  
1941 BAY STREET  
ATLANTA, GA 30067

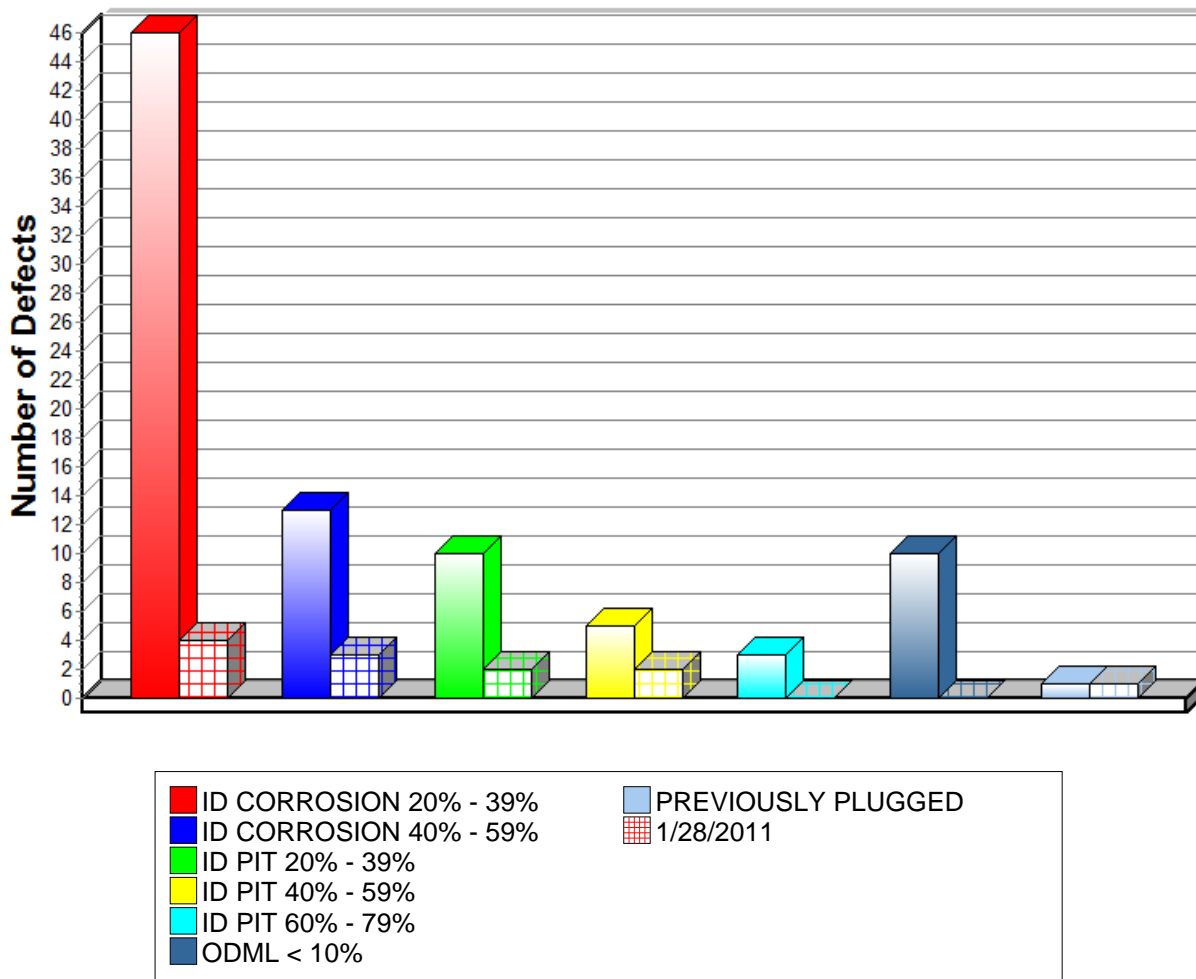
### Condenser Defects

Condenser: 186 Tubes		
Significant/Measurable Indications	Number of Tubes Marked	Percent of Bundle
ODML < 10%	10	5.38
ID CORROSION 20% - 39%	46	24.73
ID CORROSION 40% - 59%*	13	6.99
ID PIT 20% - 39%	10	5.38
ID PIT 40% - 59%*	5	2.69
ID PIT 60% - 79%*	3	1.61
PREVIOUSLY PLUGGED	1	.54
Totals	88	47.32

**\* REQUIRES ACTION**

We recommend tubes indicating ID Corrosion and/or Pitting of 40% or more be isolated from the system at this time. Damage of less than 40% requires no immediate corrective action, however, the affected tubes should be monitored for defect growth. This type of damage is usually progressive and results from chemical or biological attack.

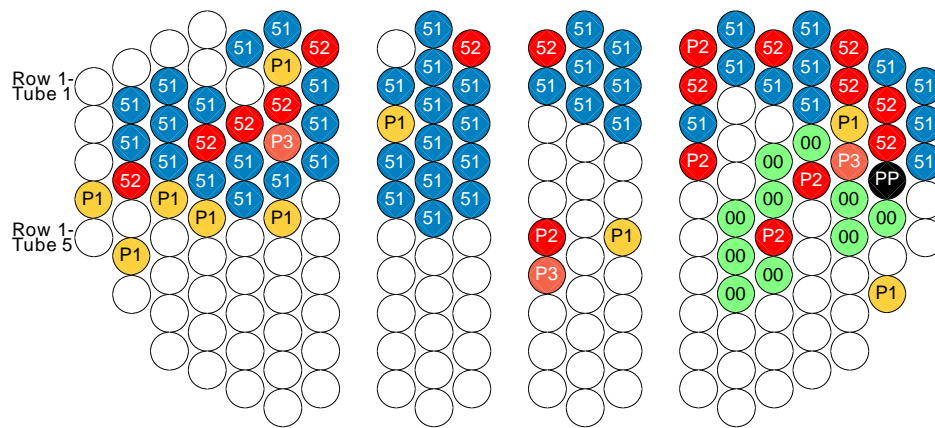
# Condenser Section

NOTE: Although not marked on the tube chart, the majority of the tubes gave indications of minor ID Corrosion. See Strip Chart Recordings. Only the more significant corrosion was marked to keep the tube chart neat and legible, and to better illustrate any major defect patterns that may exist.

- 00 = ODML < 10%
- 51 = ID CORROSION 20% - 39%
- 52 = ID CORROSION 40% - 59%      **REQUIRES ACTION**
- P1 = ID PIT 20% - 39%
- P2 = ID PIT 40% - 59%      **REQUIRES ACTION**
- P3 = ID PIT 60% - 79%      **REQUIRES ACTION**
- PP = PREVIOUSLY PLUGGED

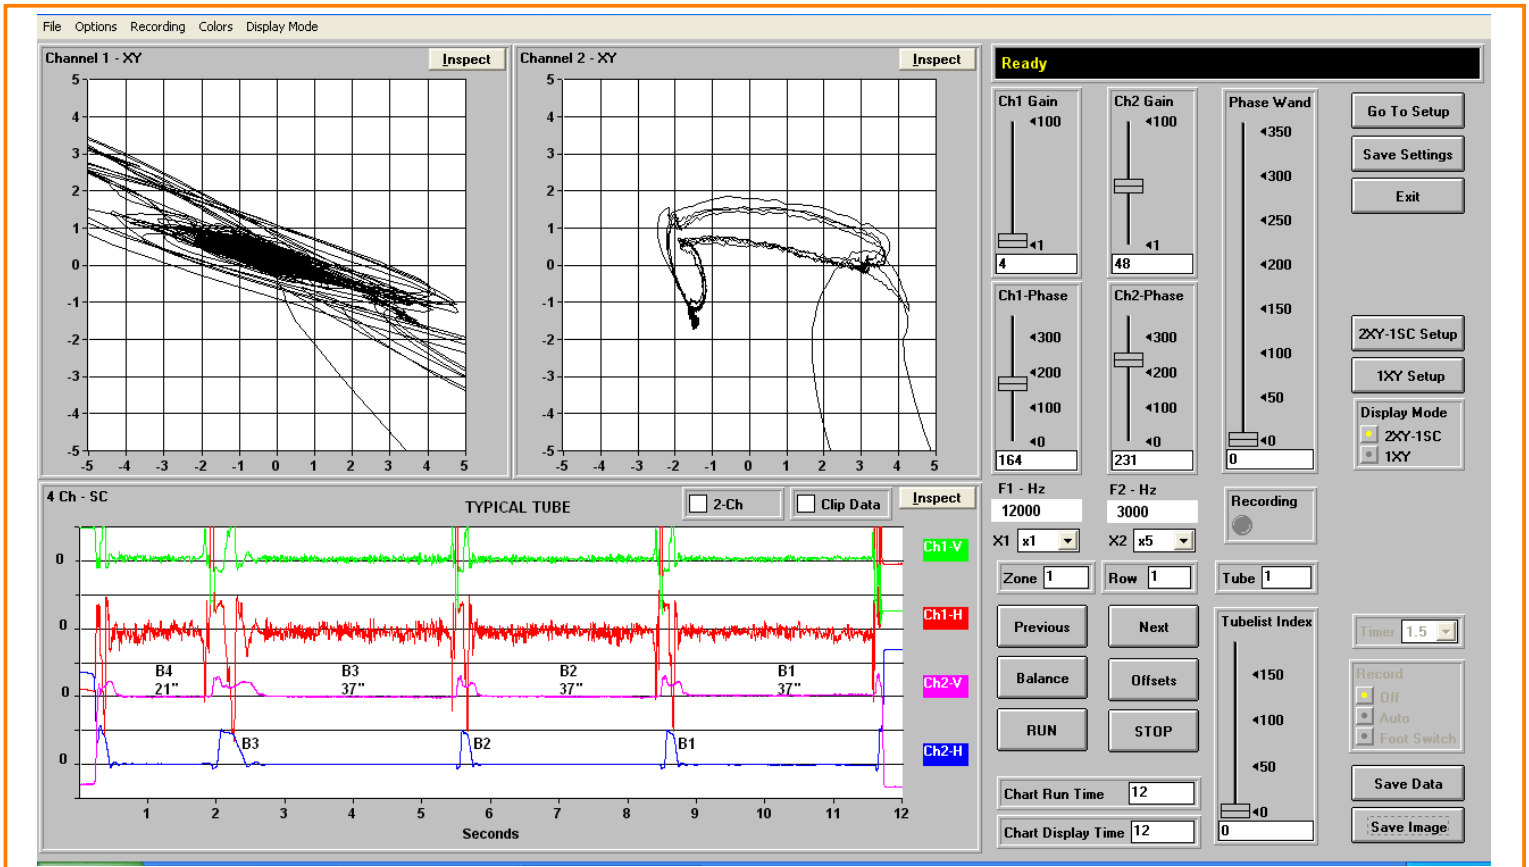
TYPICAL TUBE (Row 1 Tube 1)

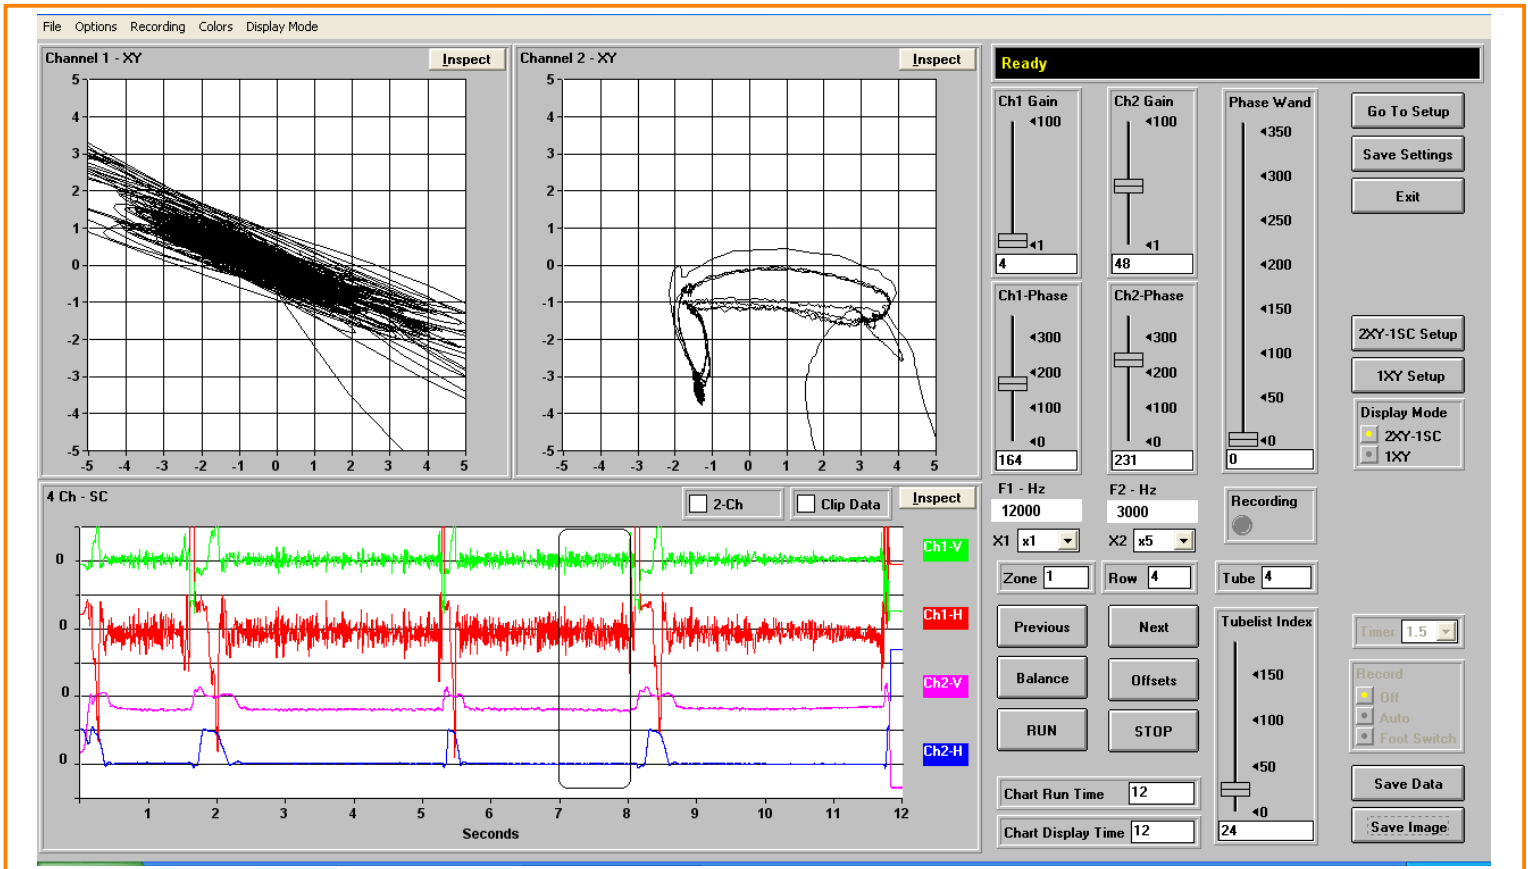
ID CORROSION 40% - 59% (Row 4 Tube 4)

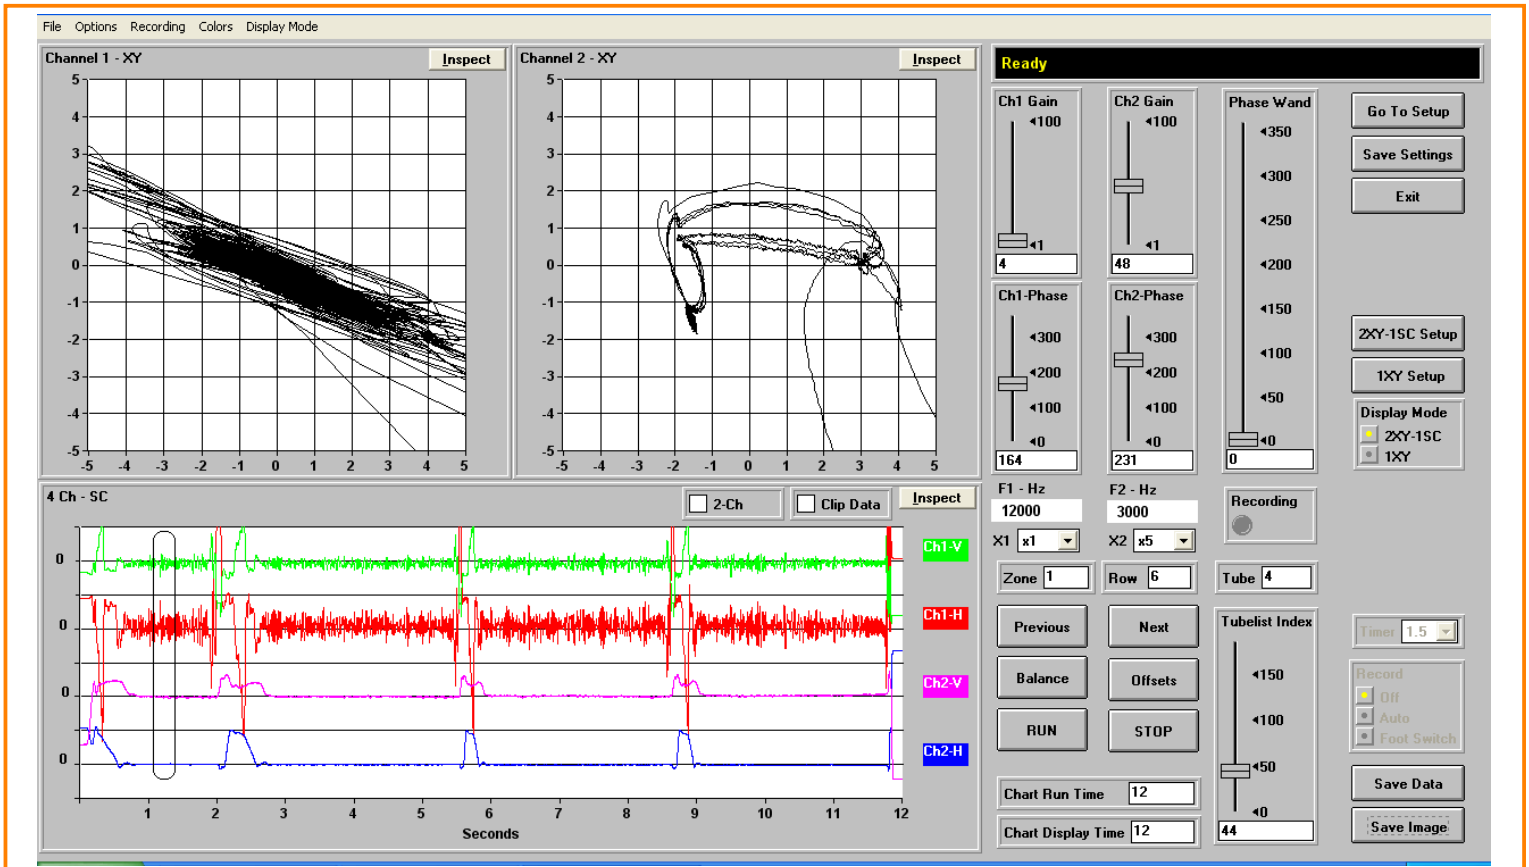
ID PIT 60% - 79% (Row 6 Tube 4)

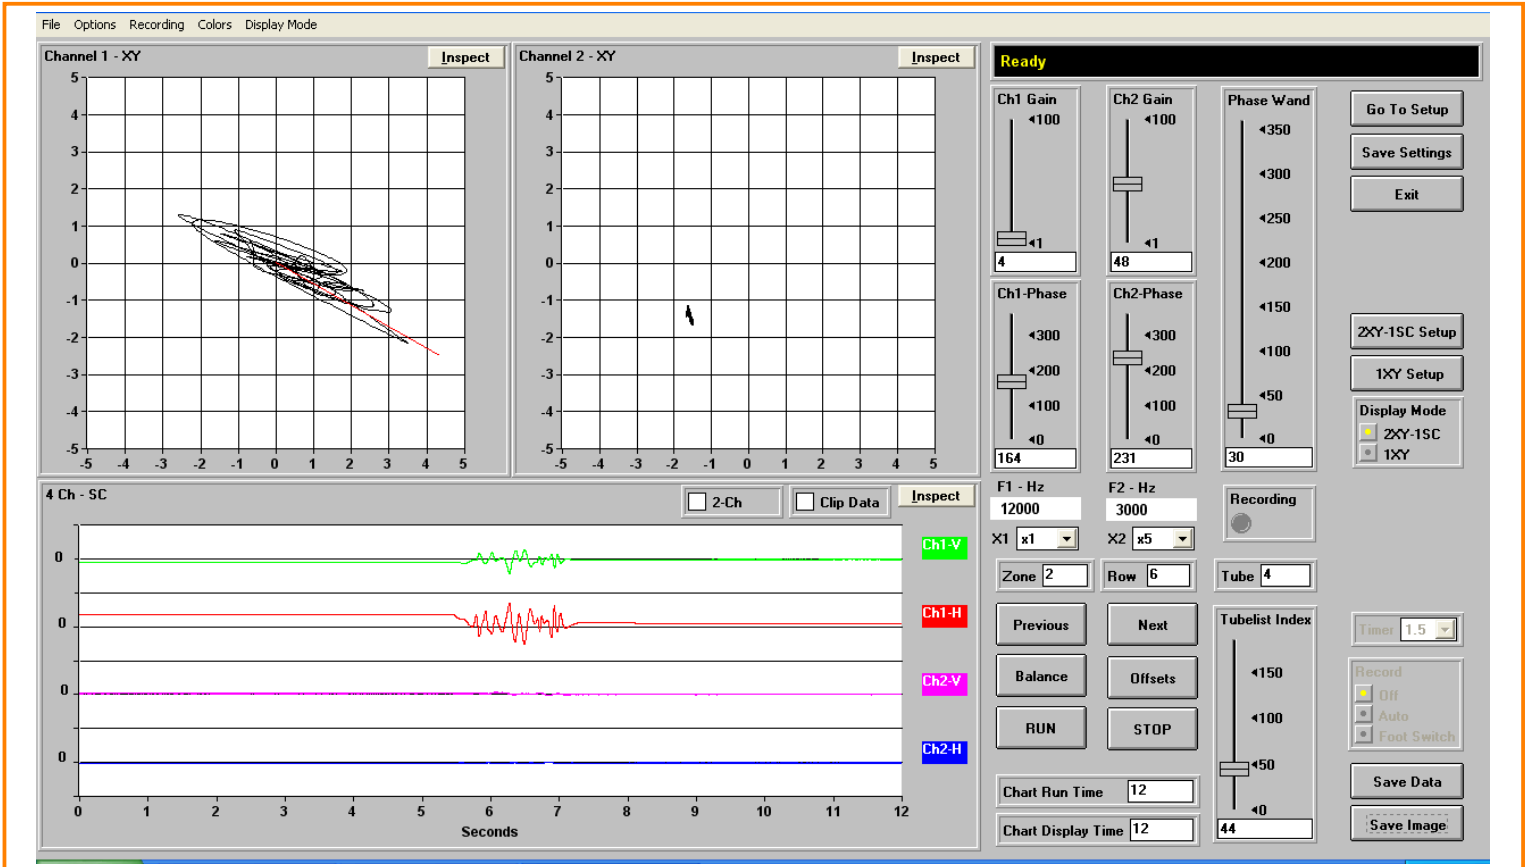
ID PIT 60% - 79% (Row 6 Tube 4)

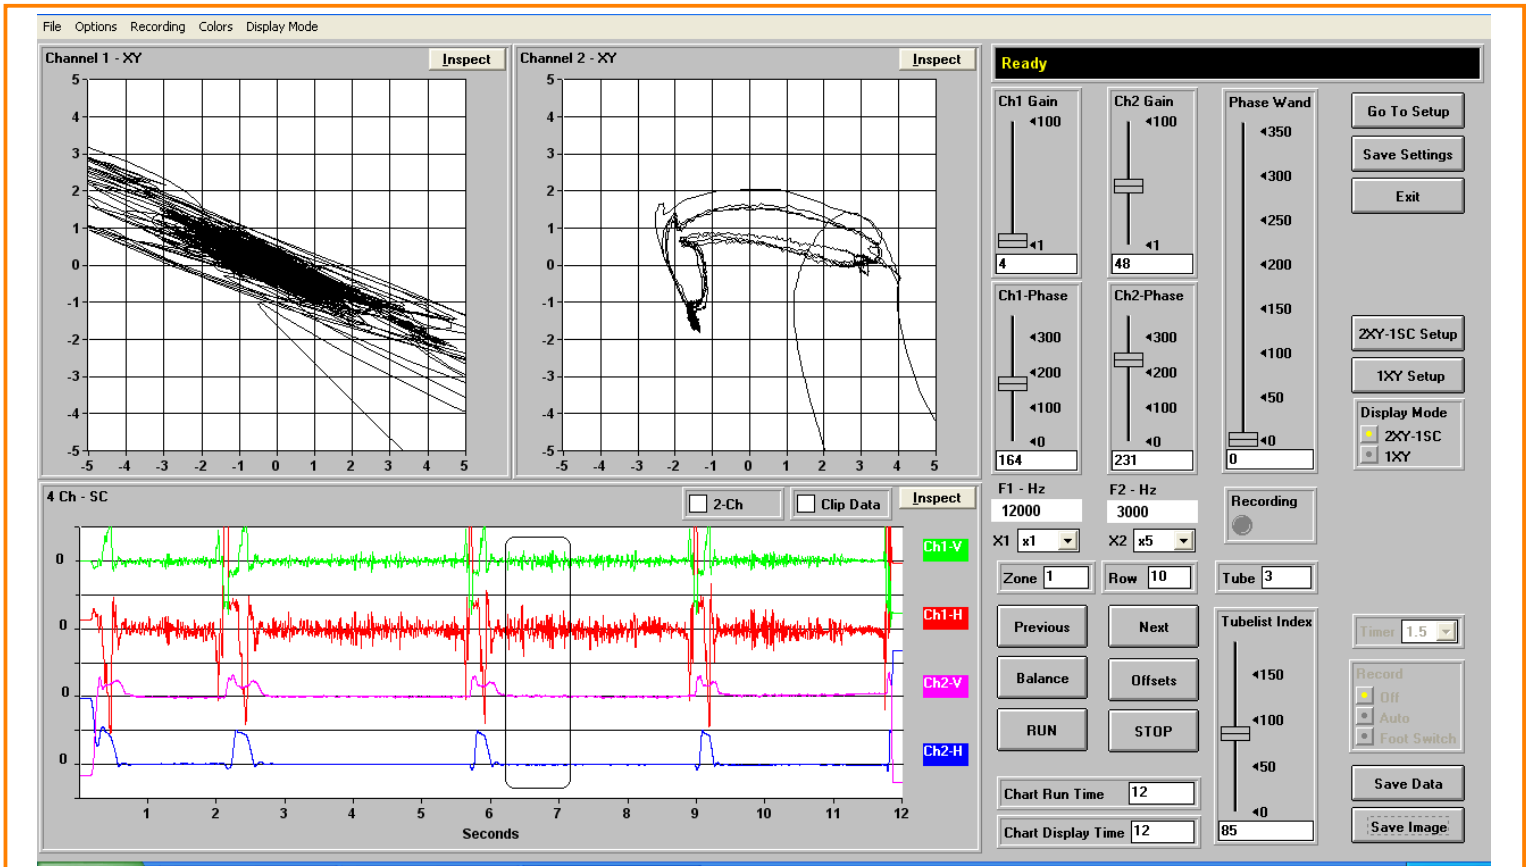
ID CORROSION 20% - 39% (Row 10 Tube 3)

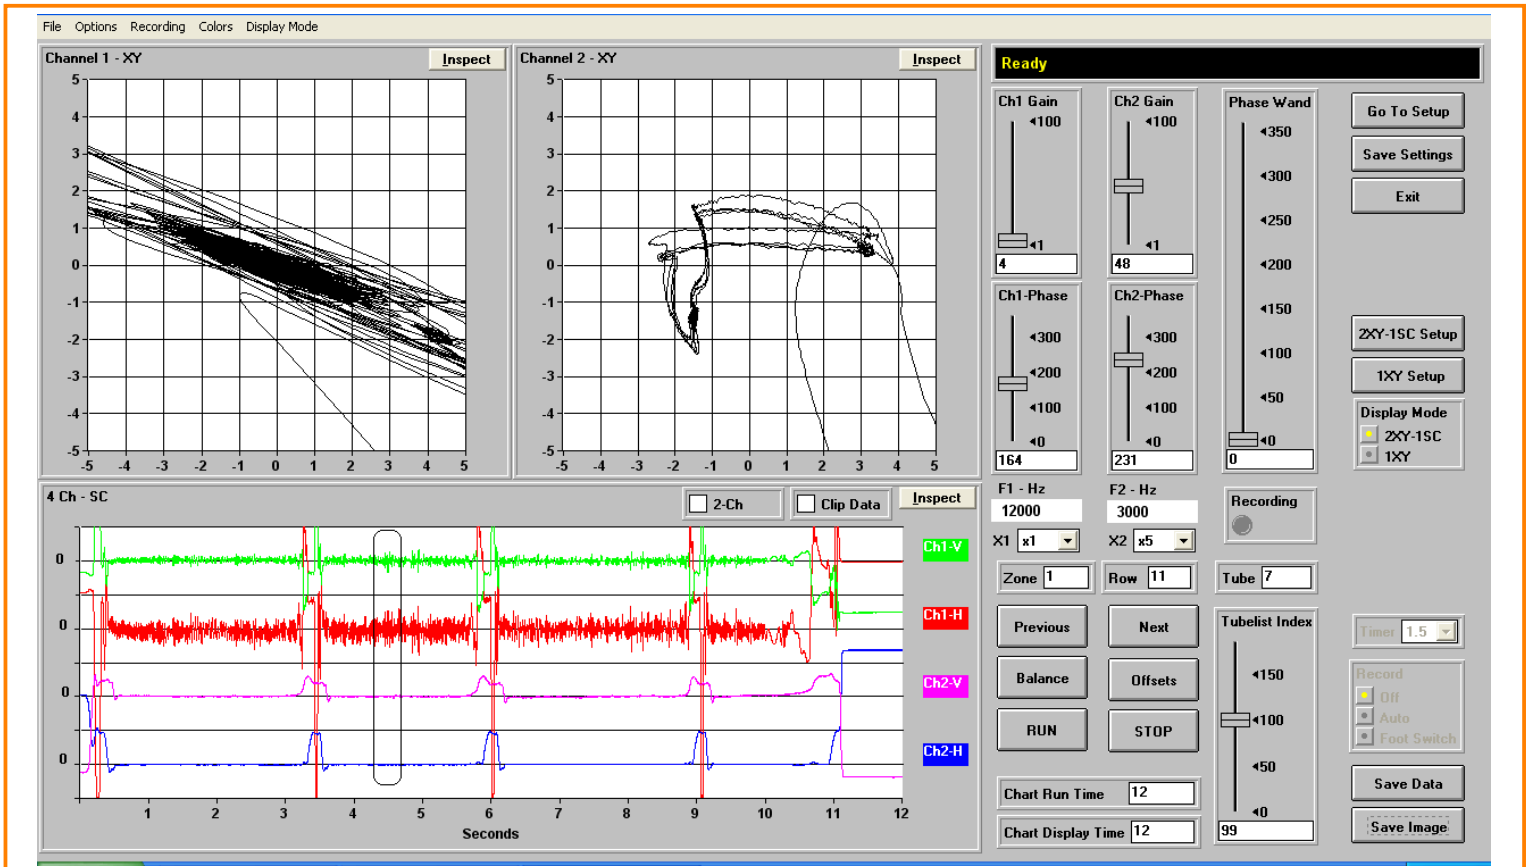
ID PIT 60% - 79% (Row 11 Tube 7)

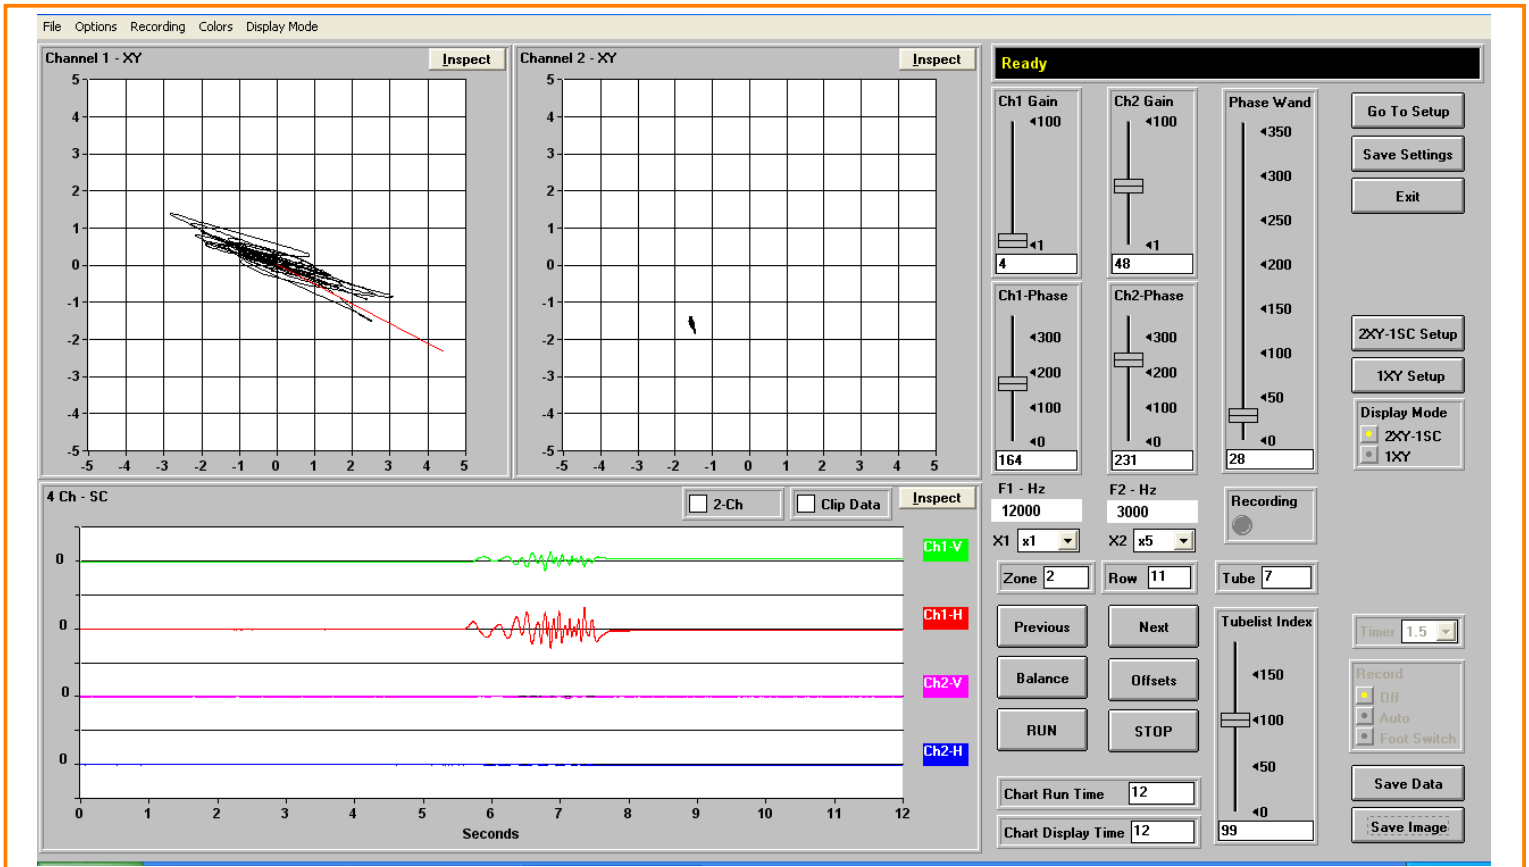
ID PIT 60% - 79% (Row 11 Tube 7)

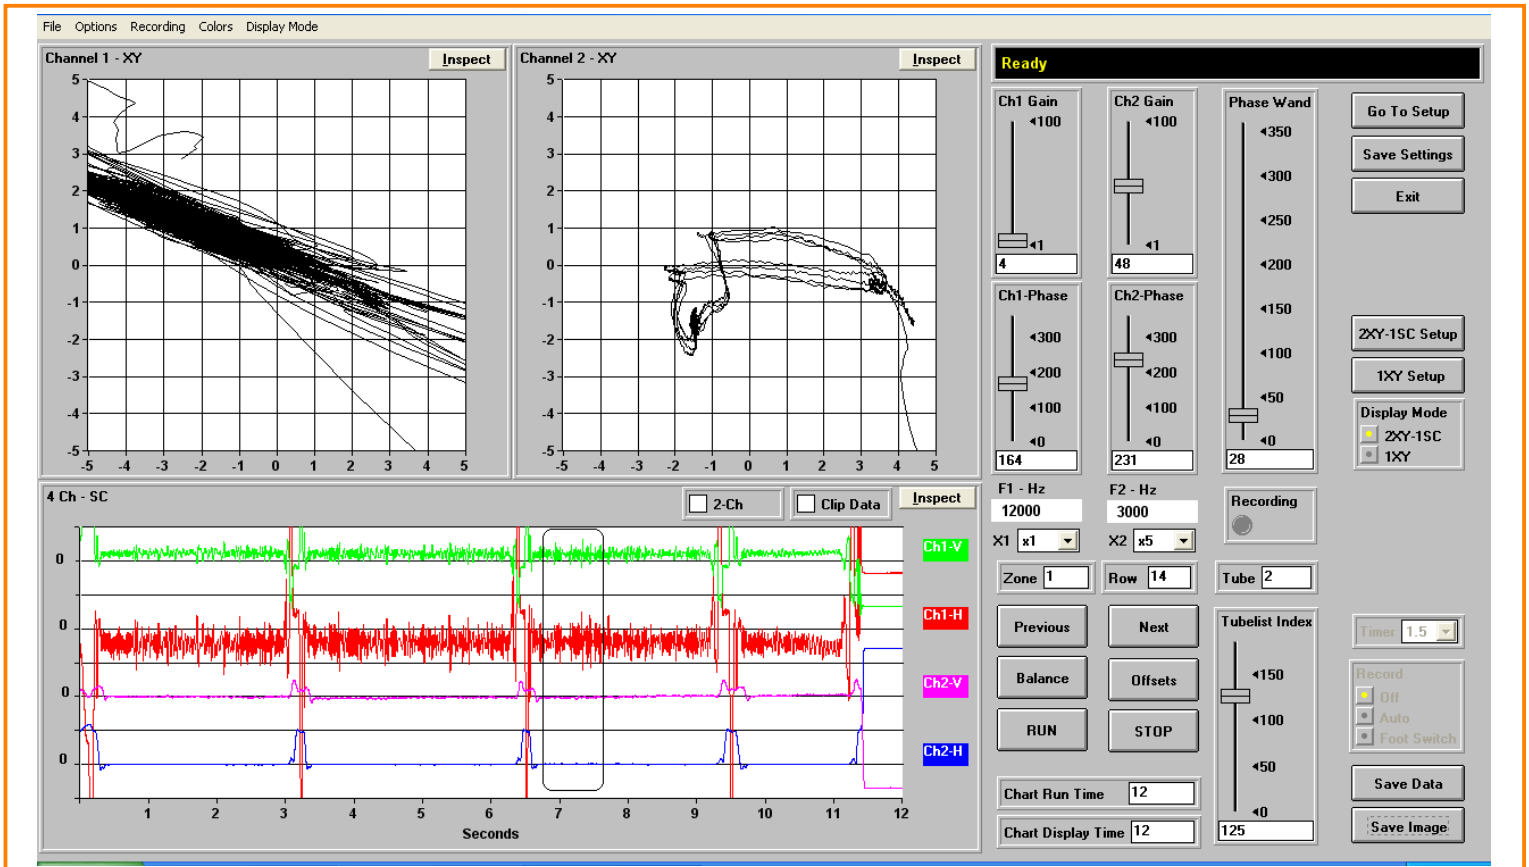
ID CORROSION 40% - 59% (Row 14 Tube 2)

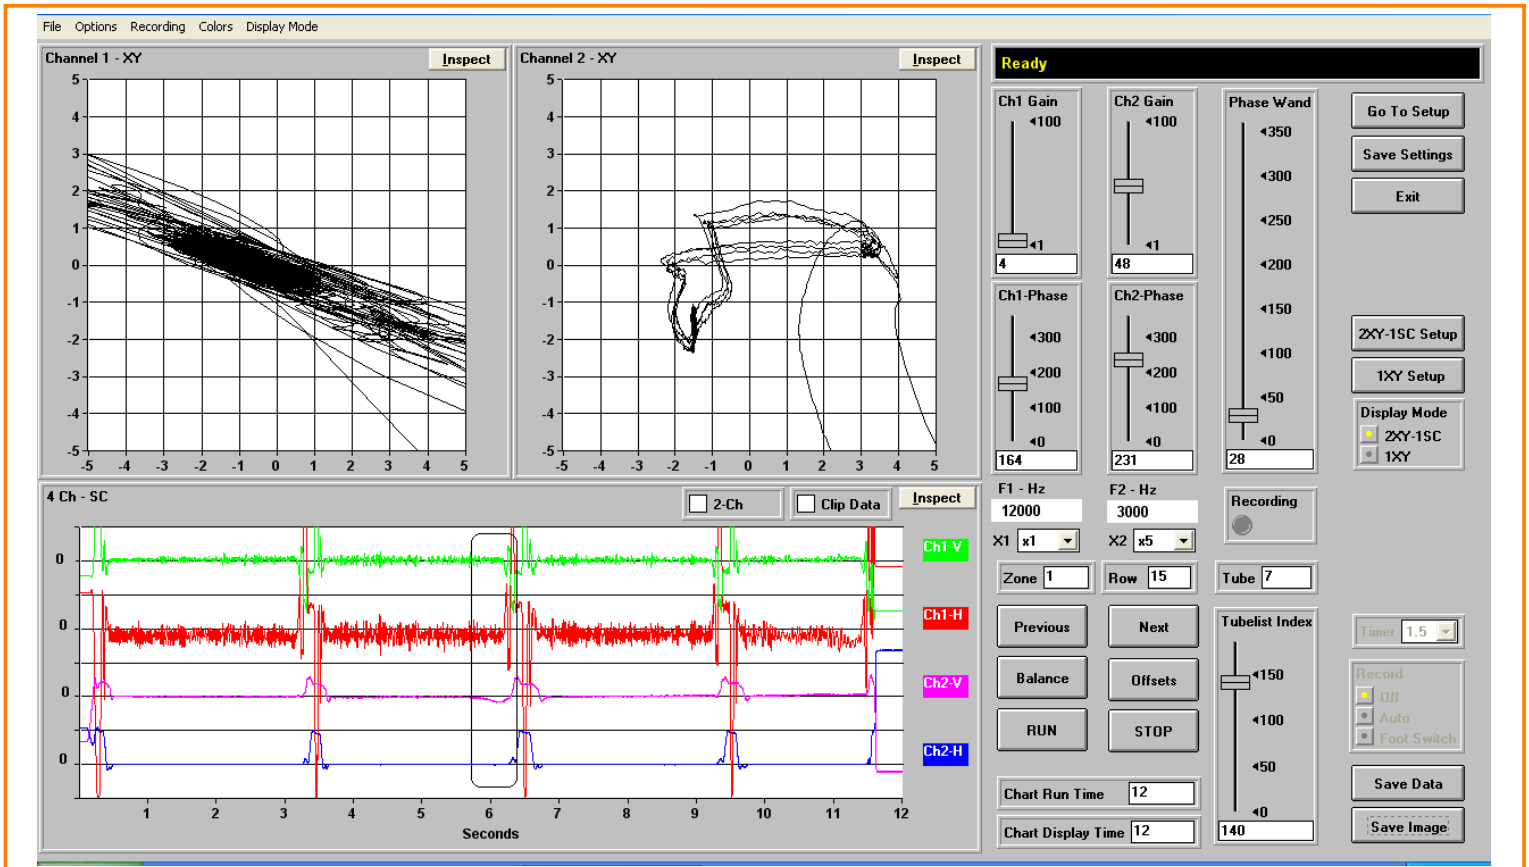
The amount of OD Metal Loss detected during this inspection is minor and requires no corrective action at the present time. This damage usually results from acids forming in the refrigerant due to moisture contamination.

ODML < 10% (Row 15 Tube 7)

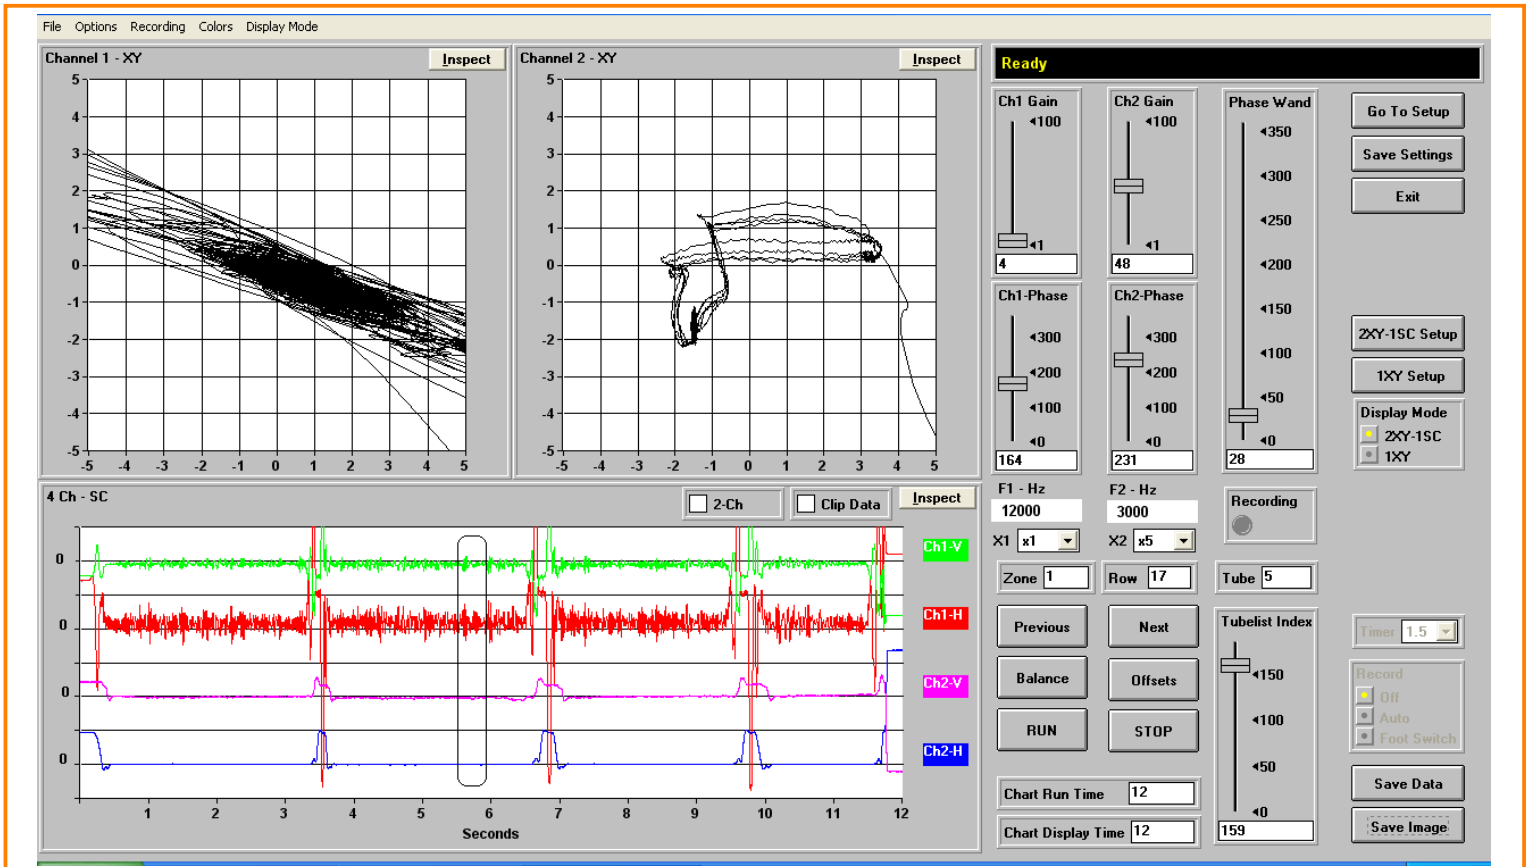
ID PIT 40% - 59% (Row 17 Tube 5)

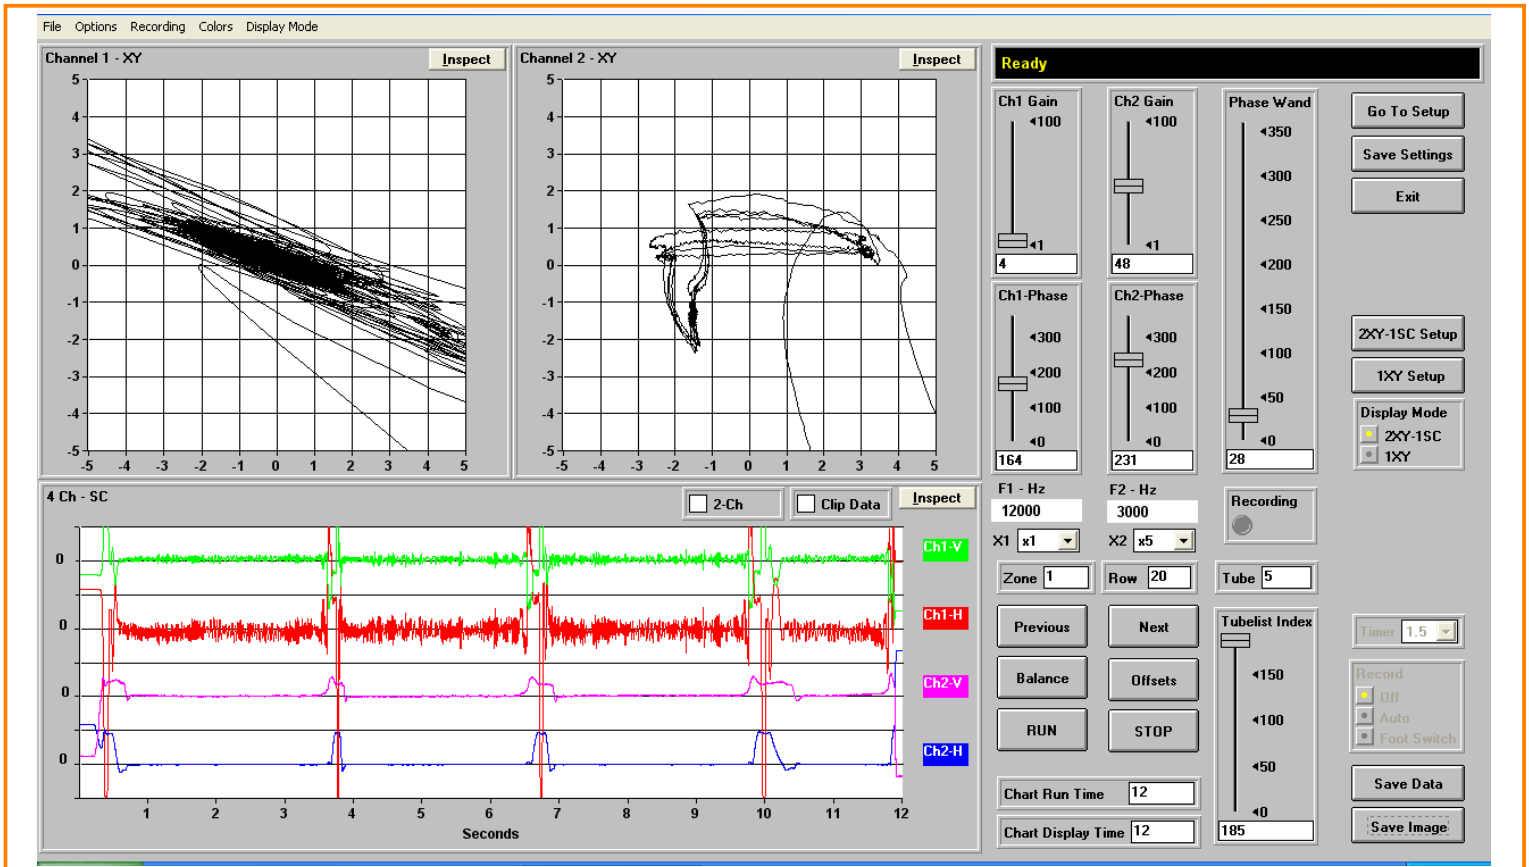
NO SIGNIFICANT DEFECTS (Row 20 Tube 5)
