Report of Flux Leakage Inspection

Eclipse: STEAM BOILER

Serial: 47153

Location: USA SCHOOL
3355 First Steet
SOMEWHERE, US 00002

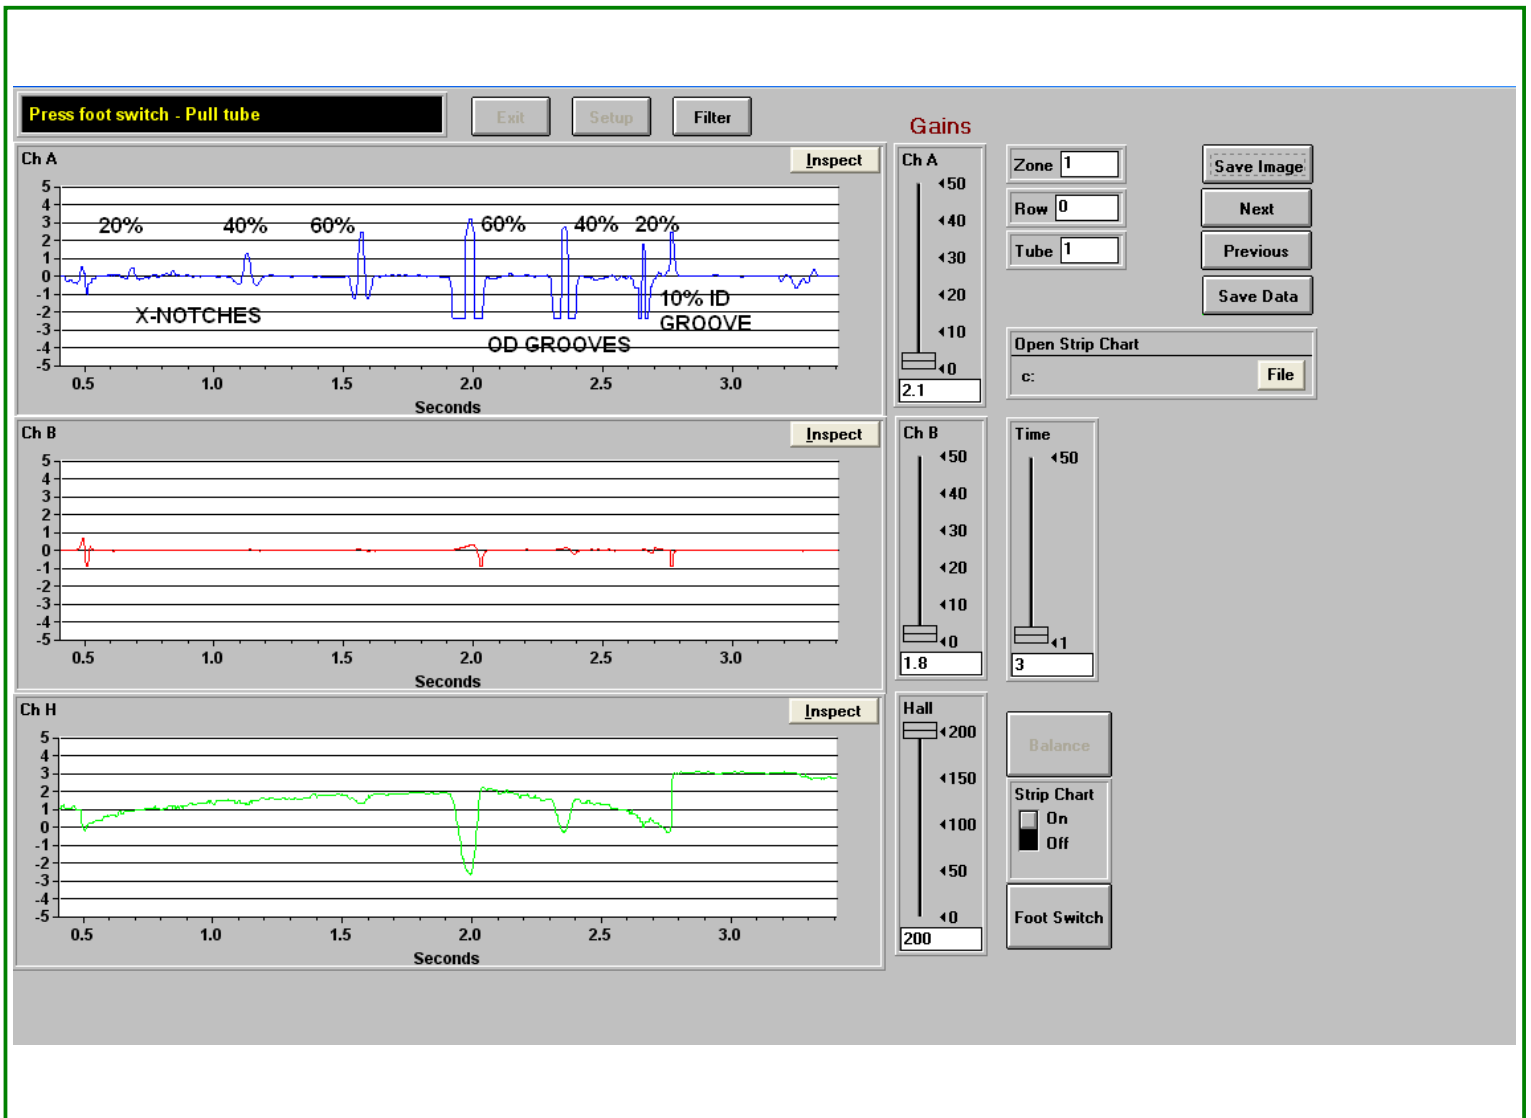
Boiler

- P6 = OD PIT 20% - 39%
- P7 = OD PIT 40% - 59% **REQUIRES ACTION**
- P8 = OD PIT 60% - 79% **REQUIRES ACTION**
- PL = POSSIBLE LEAK **REQUIRES ACTION**

We recommend tubes indicating OD Pits of 40% or more be isolated from the system at this time. Tubes indicating OD Pits of less than 40% require no corrective action but should be monitored for defect growth.

We recommend tubes marked for leaks be isolated from the system at this time.
